## VERTICAL MOVEMENTS MEASUREMENTS OF EDUCATIONAL CENTRE BUILDING OF WROCLAW UNIVERSITY OF ENVIRONMENTAL AND LIFE SCIENCES

**K. Monkolski, P. Goldyn, J. Kazak**

Institute of Geodesy and Geoinformatics  
of Wrocław University of Environmental and Life Sciences.

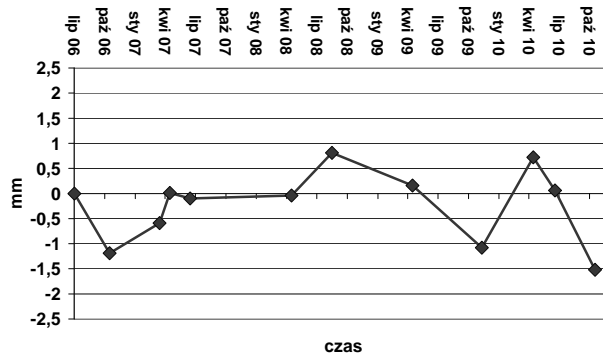
shown in Figures 2-5, it is noticeable that after the first phase, in which there is subsidence, due to dewatering ground under facility Grunwaldzki Center, following the phase of lifting, probably resulting of lifting of the ground, through mass loss from the excavation conducted under the above-mentioned object.

The phenomenon is more noticeable for bench marks No. 31 and 32 located closer to build object. In a period after June 2007, after completion of major construction works on the Grunwaldzki Center site, there is a stabilization of the controlled bench marks. A further periodical changes may arise with cyclic annual changes in water level.

Fig. 2. Graph shows vertical changes of controlled bench mark No. 7

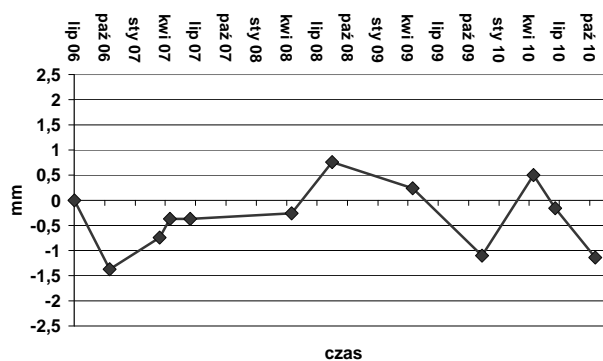
Fig. 3. Graph shows vertical changes of controlled bench mark No. 8

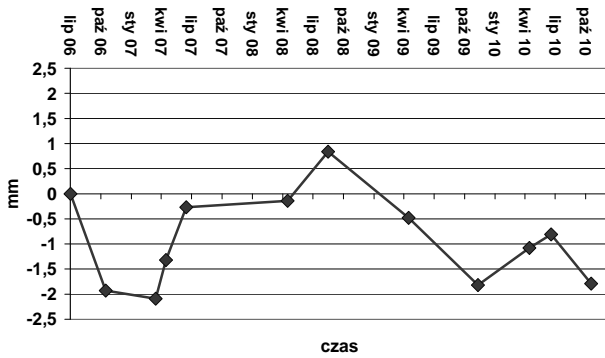
Fig. 4. Graph shows vertical changes of controlled benchmark No. 31

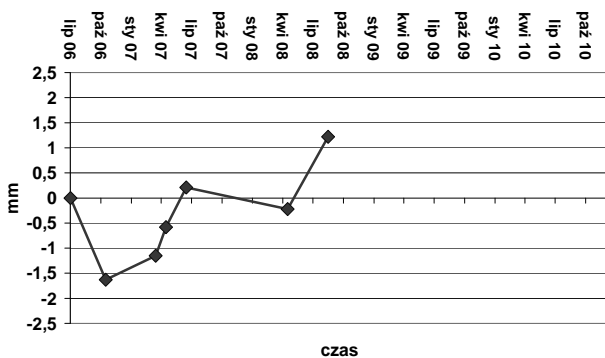
The obtained values of a height difference of controlled bench marks, in full cycle of 12 periodical measurements, are shown in Figures 2, 3, 4 and 5. Bench mark No. 32 was observed only for measurements till September 2008, because it has been destroyed during renovation works of the facade of Educational Centre Building. Analysing the vertical changes of bench marks

Fig 5. Graph shows vertical changes of controlled benchmark No. 32
