EXPERIMENTAL DIAGNOSTICS AND STATIC ASSESSMENT OF FIRE DAMAGED STEEL STRUCTURE

In the paper are presented the results of diagnostics, tests of materials, numerical modelling and static analysis of the current state of the bearing steel structure of the hall after a fire and design of the actions for the repair of the damaged steel structural members.

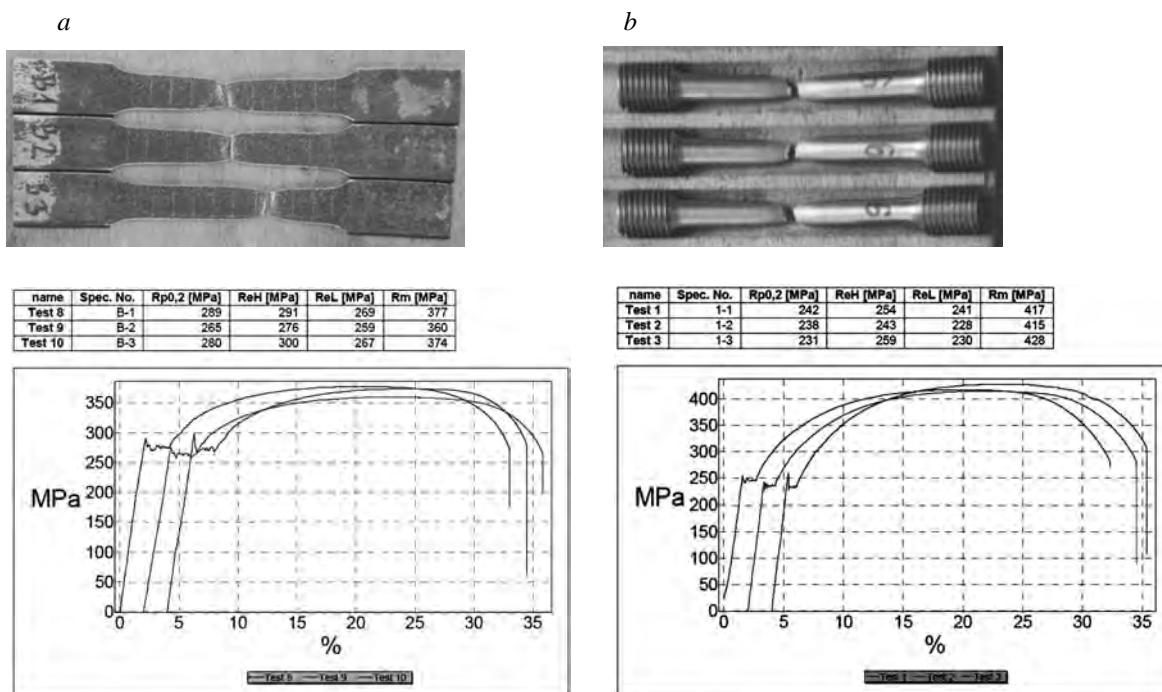
Tensile diagrams correspond to the low carbon structural steel used for welded structures. The fracture appearance corresponds to the mechanical properties evaluated. No anomalies in the behaviour of tested samples were detected.

Fig. 2. Flat testing specimens (a), cylindrical testing specimens (b) and stress-strain diagrams ($R_{p0,2} \rightarrow f_{y0,2}$, $R_{eH} \rightarrow f_{yU}$, $R_{eL} \rightarrow f_{yL}$, $R_m \rightarrow f_u$)

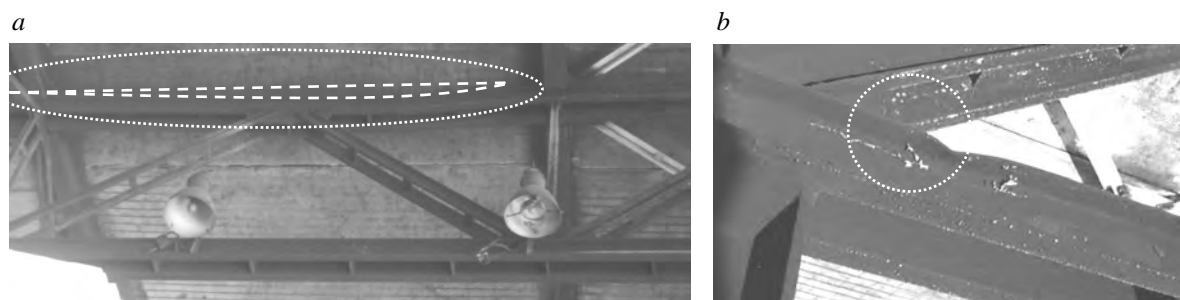
- Plastic deformations of the top chords of truss tie-beams in the 15 and 16 axes and their spatial displacement were identified as is shown in Fig. 3;
- In the bottom chords of truss tie-beams in the 15 and 16 axes local plastic deformations of the cross-sections near supports (at the steel columns) were occurred;
- Web buckling between stiffeners of the column in the 16 axis was identified;
- The main girder of the crane track is not distorted (deflection of the rail axis obtained by measurement is compensated through the necessary rectification);
- Vertical longitudinal roof bracings situated between the truss tie-beams in the 15-16 axes are deformed;
- Side horizontal roof bracings in the roof plane are not deformed.

Fig. 3. a) the deformed buckled top chord of the truss tie-beam in the 16 axis (over the outbreak of fire) b) the deformed bottom chord of the truss tie-beam in the 16 axis (over the outbreak of fire)

- Continuous geodetic measurements of the selected points in the top and bottom chords of roof trusses in the 15 and 16 axes confirmed the progressive increase of the displacements (deformations) in the horizontal transversal direction during the period of the four days. In the place of the buckled chord (truss in the 16 axis) the increment of the displacement in the horizontal direction of approximately 35 mm occurred. In the middle of the bottom chord of the truss in the axis 15 the increment of the displacement in the horizontal direction of approximately 70 mm was measured.

- Strengthening of a locally failed web of the column in the 16 axis by the addition of transversal stiffeners.
- Stabilization and disburdening of the roof truss tie-beams in the 15 and 16 axes by means of the placement of the temporary supporting columns under the purlines in the places between the 14-15, 15-16 and 16-17 axes. A temporary supporting system with the damping members may be situated on the bridge cranes.
- Removing of the roof porous concrete panels between the 14-15, 15-16 and 16-17 axes (replace them by a light-weight sandwich roof cladding).
- Strengthening of the top chords of the trusses.

Fig. 9. The strengthened top chord of the truss tie-beam (in the area over the fire)

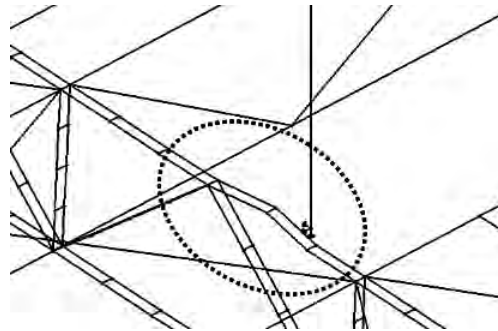
In the analysis and reliability assessment a deviation with a size of 200 mm of the top chord of the truss tie-beam in the horizontal direction was considered (Fig. 4).

Fig. 4. Computational model with the introduction of imperfections

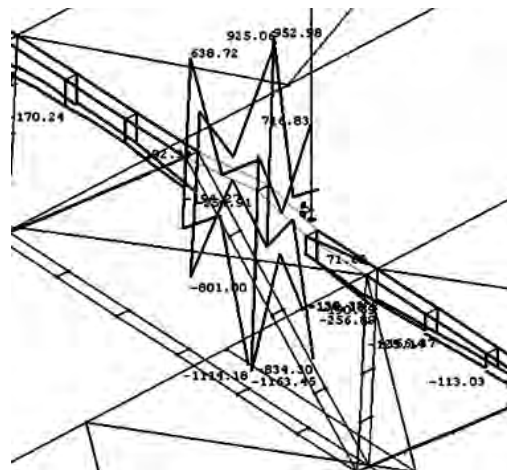
Results of the static analysis confirmed that the stresses of the top chords of the truss tie-beams (in the place of considered imperfections) are behind the elastic limit and chords are characterized by a plastic behaviour (Fig. 5).

Fig. 5. The resultant distribution of stresses in the top chords of the truss tie-beams

The maximum vertical deflection obtained from the analysis of the truss tie-beam with imperfections loaded by its self-weight and by a weight of the roof cladding is 137 mm.

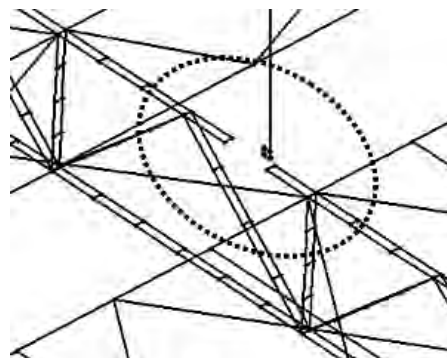
In order to investigate the behaviour of the diminished steel structure an interrupting of the top chords of the truss tie-beams were modelled too and the analysis of the diminished structure was performed (Fig. 6 and Fig. 7).

Fig. 6. Static computational model of the top chords of tie-beams with an interrupting

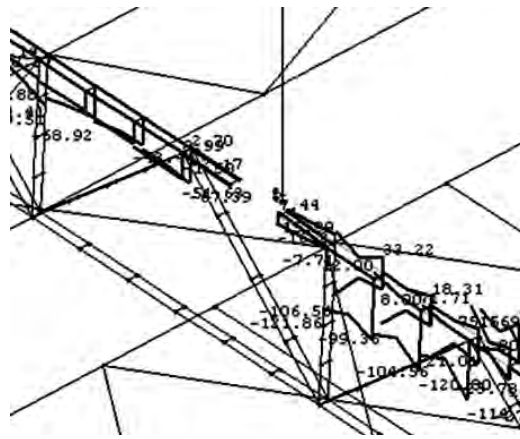
Fig. 7. The resultant distribution of stresses in the top chords of the truss tie-beams

- Current behaviour of the roof trusses in the 15 and 16 axes (an area of the fire) is behind the limits of the allowable stresses and deflections. Consequently, the roof trusses do not fulfil criteria of the reliability defined by the ultimate limit states as well as by the serviceability limit states.
- Columns fulfil conditions of reliability in the case, that the local damaged (buckled) web of the column in the 16 axis will be reinforced.

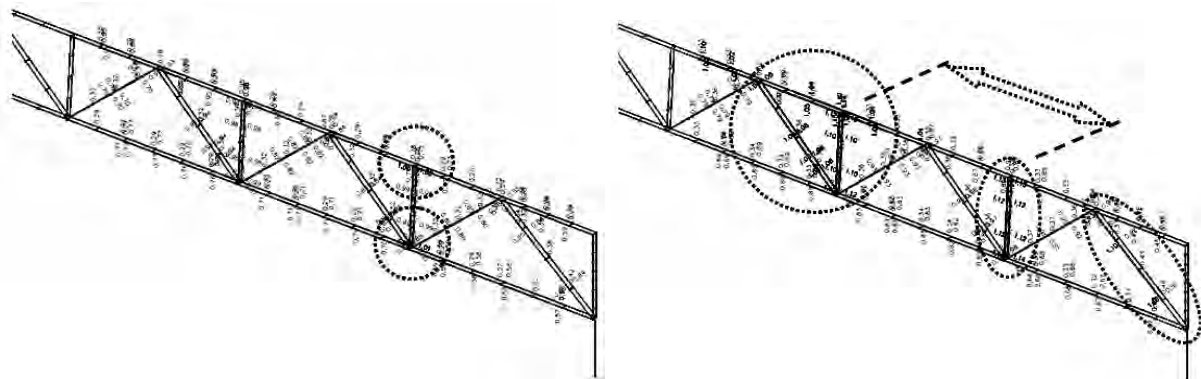
a) Temperature-time area: 16 minutes

b) Temperature-time area: 20 minutes

Fig. 12. Assessment of the individual members of the steel truss tie-beam in the temperature-time area with respect to the critical temperature of the material, with the marked members which have reached temperatures higher than the critical temperature, deformation zone is marked (Fig. 3a)

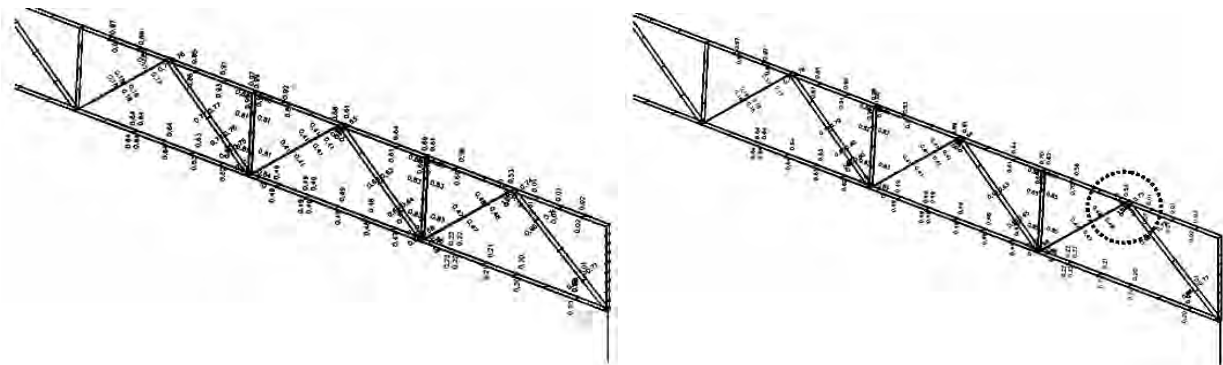
a) Resistance: 9 minutes and 15 seconds

b) Resistance: 10 minutes

Fig. 13. Resistance of the individual members of the steel truss tie-beam depending on the time, where the members with the unsatisfactory resistance are marked, deformation zone is marked (Fig. 3a)

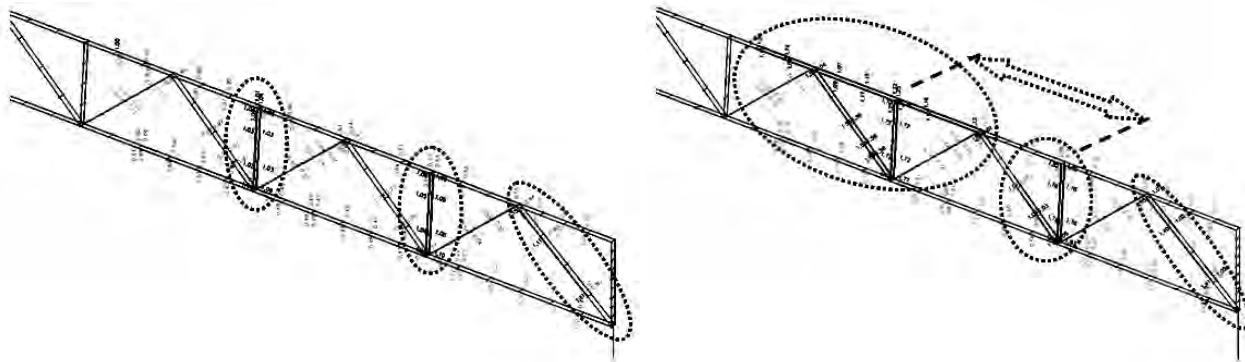
a) Resistance: 15 minutes

bd) Resistance: 20 minutes

Fig. 14. Resistance of the individual members of the steel truss tie-beam depending on the time, where the members with the unsatisfactory resistance are marked, deformation zone is marked (Fig. 3a)

On the basis of the analyses, it can be alleged that the resultant time of the resistance of the steel truss tie-beam as well as results obtained by the solution in the temperature-time area are comparable with those determined on the basis of the real behaviour of the steel roof truss tie-beams at the fire, when the direct flame intensity affected on them was of approximately 10 minutes. Buckling of the top chord of the truss tie-beam (Fig. 3a, Fig. 14b and Fig. 12b) confirms the correctness of computational models and accuracy of numerical analyses used in this study.
