APPLICATION OF CFD FOR INTERIOR FLOW ANALYSIS INFLUENCED BY EXTERIOR CONDITIONS

The aim of the paper is the presentation of application CFD analysis for interior flows in chimneys and flats in a building. It is a summary of a case study of fatal intoxication by carbon monoxide coming from a gas heater of flowing water at a bathroom. That kind of accidents mostly happens due to problems with ventilation and very popular old construction gas water heaters. Closed, airtight windows are the main causes of the production of carbon monoxide but sometimes wrong construction of the chimney outlets versus the roof shape causes the backdraught of combustion products. The paper deals with an accident which took place in one of Polish cities. Gas heater of flowing water installed in a bathroom at the first floor was connected to the vent pipe with a low outlet. During windy weather conditions, at the end of October, so in a cold season, one of the inhabitants of the apartment died in bathroom due to carbon monoxide intoxication.

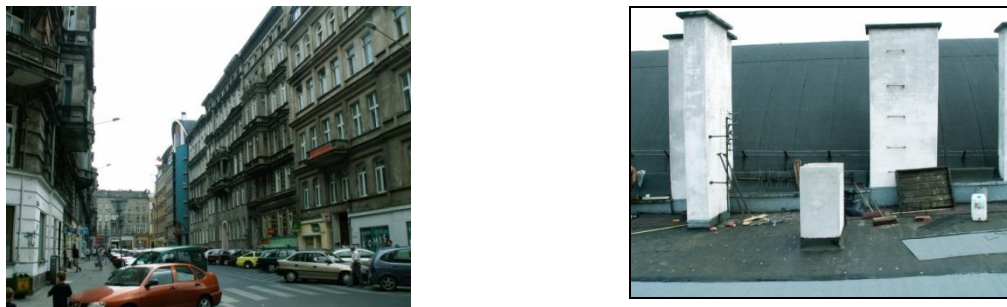
Fig. 1. The view of the new building from the street and of the outlets after adjustments

Other outlets' heights have not been changed because they were located further than 10 m from the top of the roof, thus they were outside the distance given in the Standard. One of the outlets remaining at its primary height was originally an outlet of the ventilation duct and to this vent duct a flowing water gas heater was connected in an apartment at the second floor. Consequently, the outlet's function was changed to an exhaust duct outlet. However, the construction of the chimney remained untouched, the chimney had two side wall outlets left as designed for a ventilation duct outlet.

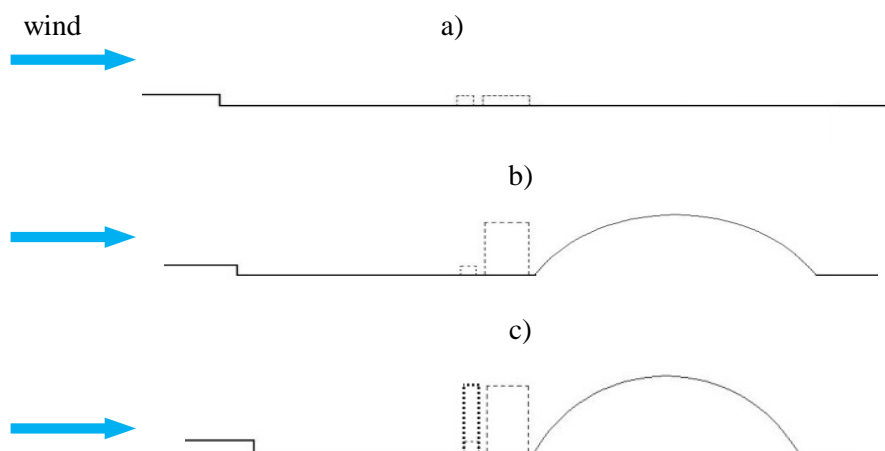
The new roof has changed the aerodynamic characteristics of the neighboring buildings, especially around the chimney outlets of the ventilation and exhaust ducts. Some of the chimneys' heights have been changed to fulfill the requirements of the Polish Standard (PN-89/B-10425).

Fig. 2. A cross-section of the roofs: a – before the construction of the arched roof; b – after the construction and c – the height of a chimney as recommended. Wind direction is marked

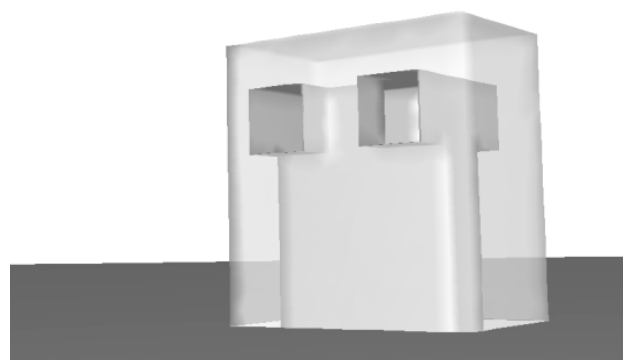
Fig. 4. The view of the outlet of the chimney during the accident. Wind direction was parallel to the walls with the outlets

The chimney protruded over the roof surface by about 0.6 m, the centers of the two outlets were at 0.4 m above the roof surface.

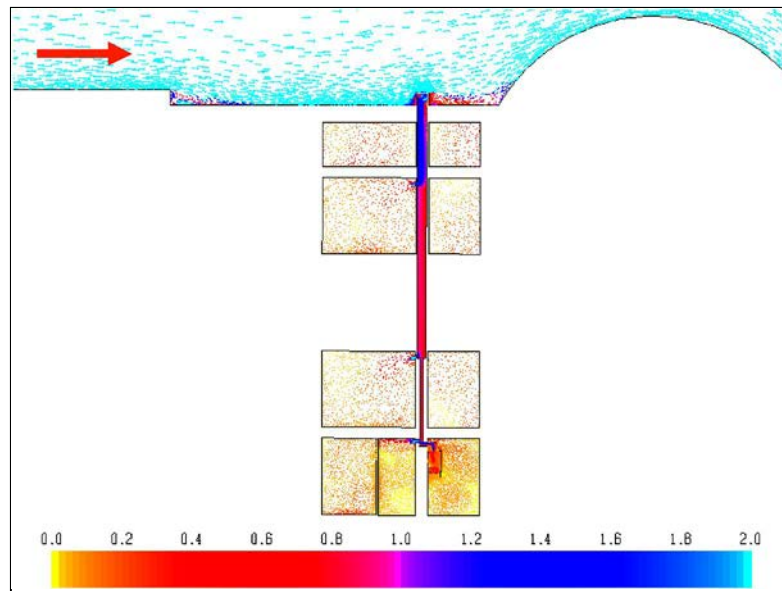
Fig. 7. Exhaust chimney duct and the connected rooms

The discharge of fumes was blocked by the cold air from the outside in the long chimney duct. The flow in the chimney was reversed due to the influence of the wind. Higher chimneys that served for the ventilation of the same apartment had outlets in the area of higher wind speed because the outlets were higher and closer to the arched roof.

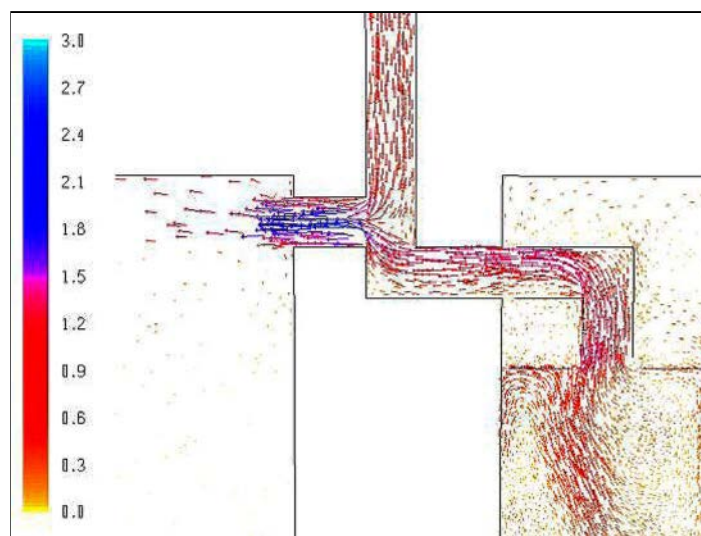
Results. After conducting the analysis the following conclusions were reached. First of all, resulting from the existing construction, features of the chimney; as well as the external conditions during the accident, in the initial phase of the water heater operation the products of combustion were not discharged upwards through the chimney but returned into the bathroom through the small fan outlet of the former ventilation duct above the place where the exhaust pipe was connected to the ventilation duct (Fig. 8).

Fig. 8. Wind speed vectors in the cross-section of the chimney near the connection of the gas heater

The backflow of fumes in the chimney also occurred after the heater had been turned off. Switching the heater on an off several times in the condition of the oxygen deficiency in a flat, led to the gradual increase of fumes and carbon monoxide concentration in the bathroom and in the entire apartment, and in the end to a fatal accident. There were 6 persons slept in the apartment at the night before the accident and the deceased has been the last person to use the bathroom in the morning.

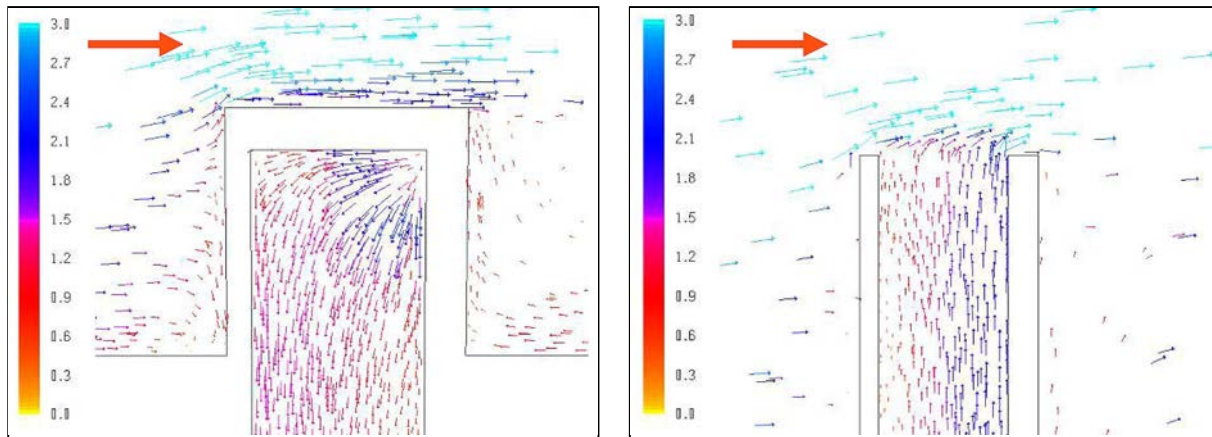
Fig. 9. Wind speed vectors in the cross-section of the chimney near the chimney outlet. Left: the existing construction; right: the recommended construction of the chimney. Wind direction is marked by an arrow

The problem of the cold air influx from the outside to the chimney can be eliminated by increasing its height to the similar height of all the other chimneys, as well as moving the outlet of the duct to the top of the chimney from the side walls (Fig. 9). The last improvement has been implemented in compliance with the Polish Standard (PN-89/B-10425).
