## CONDITIONS OF EXISTING RESIDENTIAL BUILDINGS 50–60 YEARS AND MISTAKES OF THEIR CONSTRUCTION

As a real example of such a house where there were shortcomings in construction, a residential house in Drohobych was considered, where a four-storey building collapsed. The design scheme and basic structures of the building are described. Main defects and damage to the building, including those that appeared after the collapse, are presented. Using the finite element method in LIRA-SAPR, the models of the parts of the residential building that remained after the collapse were calculated. Tests were carried out on specimens of bricks taken directly at the site of the collapse, on the basis of which the strength of masonry was determined. The theoretical results of the calculations are compared with the actual condition of the building parts.

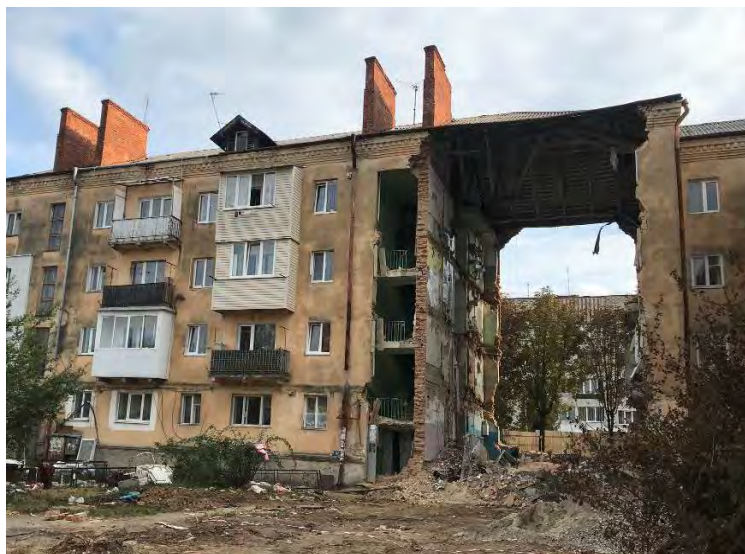
- collapse of building structures of a part of a building of all 4 floors (Fig. 2);
- basement walls and basement walls, no waterproofing;
- visible loss of stability of the middle bearing wall of the basement, vertical cracks in the wall with opening up to 10 mm in height of the bearing brick wall with the destruction of the masonry (Fig. 3). No brickwork of the basement walls. Wrapping of walls, vysolyas, fungus damage, destruction of bricks, as well as weathering and loss of strength of seam solution;

*Fig. 2. The collapse of part of the building*

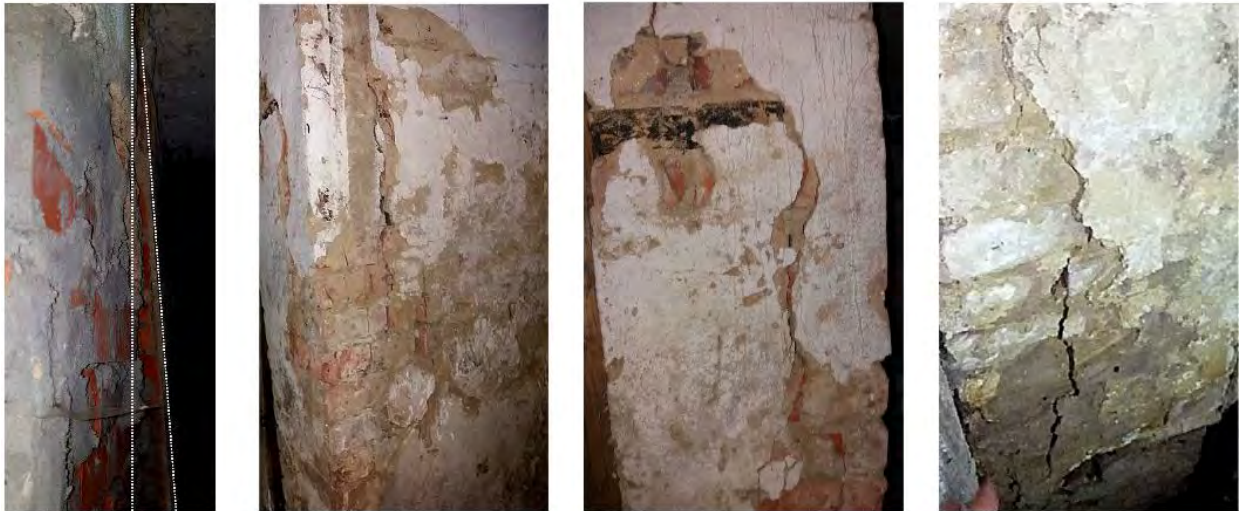
Fig. 3. Visible loss of resistance, as well as vertical and horizontal cracks in the middle bearing wall on axis B in axes 6–8

– low grade of brick and mortar, which is confirmed by laboratory tests.

As can be seen from the calculations – the compression stresses that occur in the walls of the middle bearing wall of the right side of the building, along the axis B in the axes 6–8, significantly exceed the bearing capacity of the brickwork. This phenomenon is also confirmed by the results of the survey of the building where the emergency walls were identified (Fig. 3).

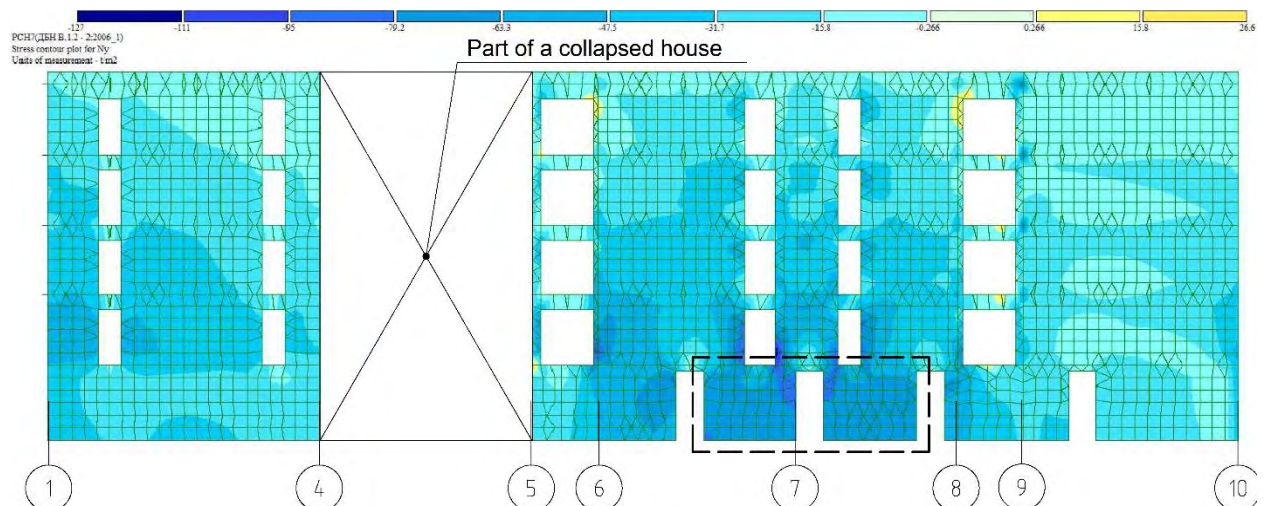
The design models of the right and left parts of the building were created, on the basis of which the distribution of stresses in the middle bearing and the most loaded walls of the right part, along axis B, in axes 1–10 (Fig. 4) was obtained.

Fig. 4. The distribution of stresses in the middle bearing walls along the axis B, in the axes 1–10, after the collapse

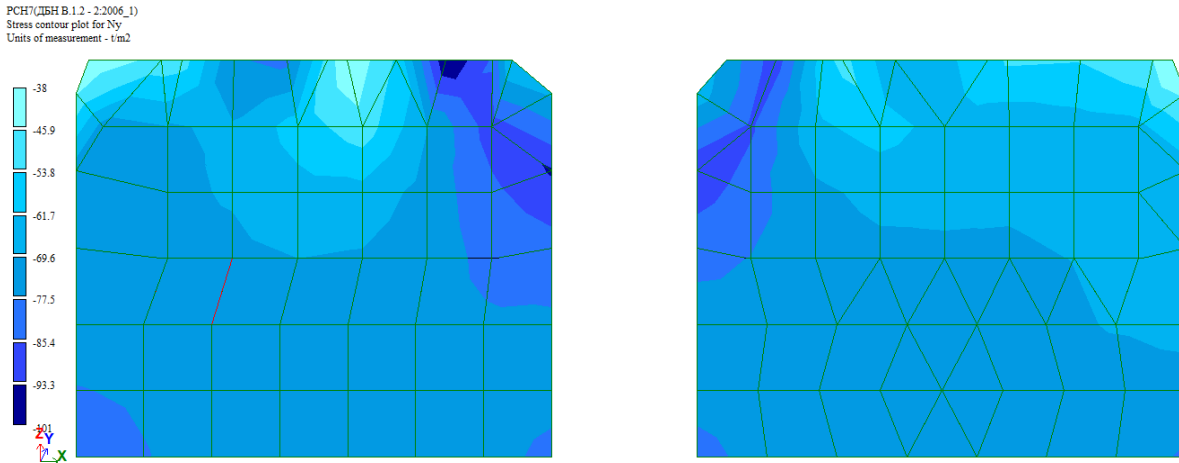
Fig. 5. Distribution of stresses in the basement walls of the right part of the building along axis B, in axes 6–7 and 7–8

The maximum stresses in the basement walls along axis B, in the axes 6–7, 7–8 exceed the allowable values of compressive strength of masonry  $R = 29,56 \text{ т/м}^2$ .

$$N_y = -38 \dots -101 \text{ т/м}^2 > R = 29,56 \text{ т/м}^2.$$

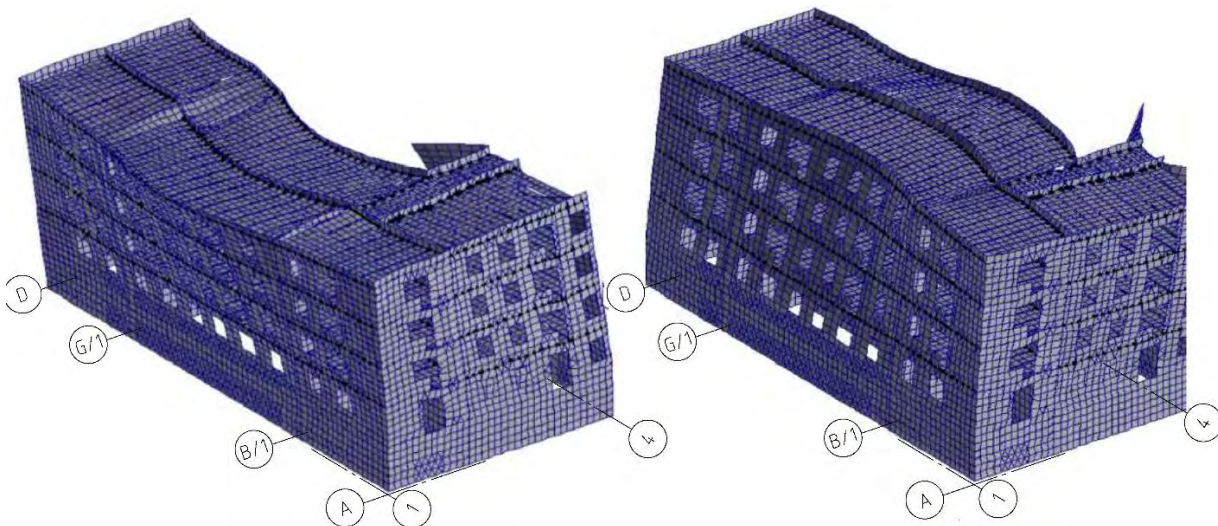
To analyze the possible impact of the collapse on a part of the building, in axes 1–3, AD, a dynamic calculation was made of the possible impulse that caused the collapse, which allowed to obtain the character of the movement of the building structures from fluctuations, in particular in Fig. 6 shows the nature of the movement from the 2nd translational form of oscillations.

Fig. 6. The nature of the movement of building structures of the left part of the house after the collapse of the 2nd translational oscillation

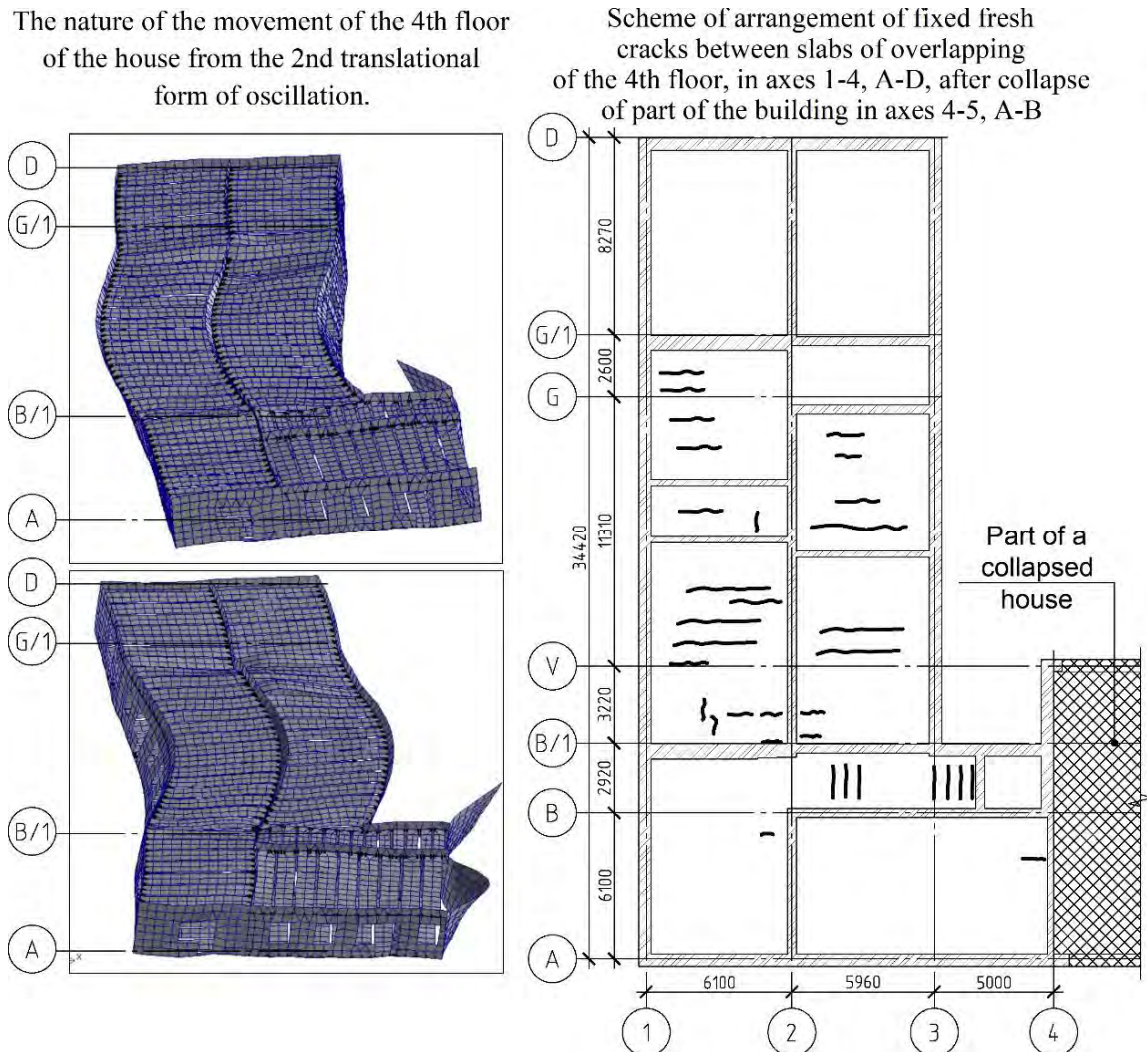
Such character of displacements is confirmed by the results of the survey presented on the scheme of location of defects with fixed fresh cracks between slabs of overlapping and at the top of partitions at the junction with the overlapping disk of the 4th floor of the left part of the building (Fig. 7).

Fig. 7. Comparison of the nature of the movement of the building structures of the left part of the house after the collapse from the 2nd translational oscillation with the actual placement of fresh cracks formed after the collapse of part of the building

Throughout the building, there are cracks under the floor slabs in the ceiling, as well as fresh cracks between the seams of the floor slabs, indicating the movement and disturbance of the flooring discs due to the impact caused by the collapse of the structures in axes 4–5, AB. These defects were further confirmed by the results of the dynamic calculation, using the finite element method in the PC “Monomakh-SAPR”, which allowed to obtain a similar nature of the movement of the overlapping disks of the building.
