10.3 Investigation of corrosion damages of heat-exchanging tubes a steam generator pgv-1000 NPP of Ukraine

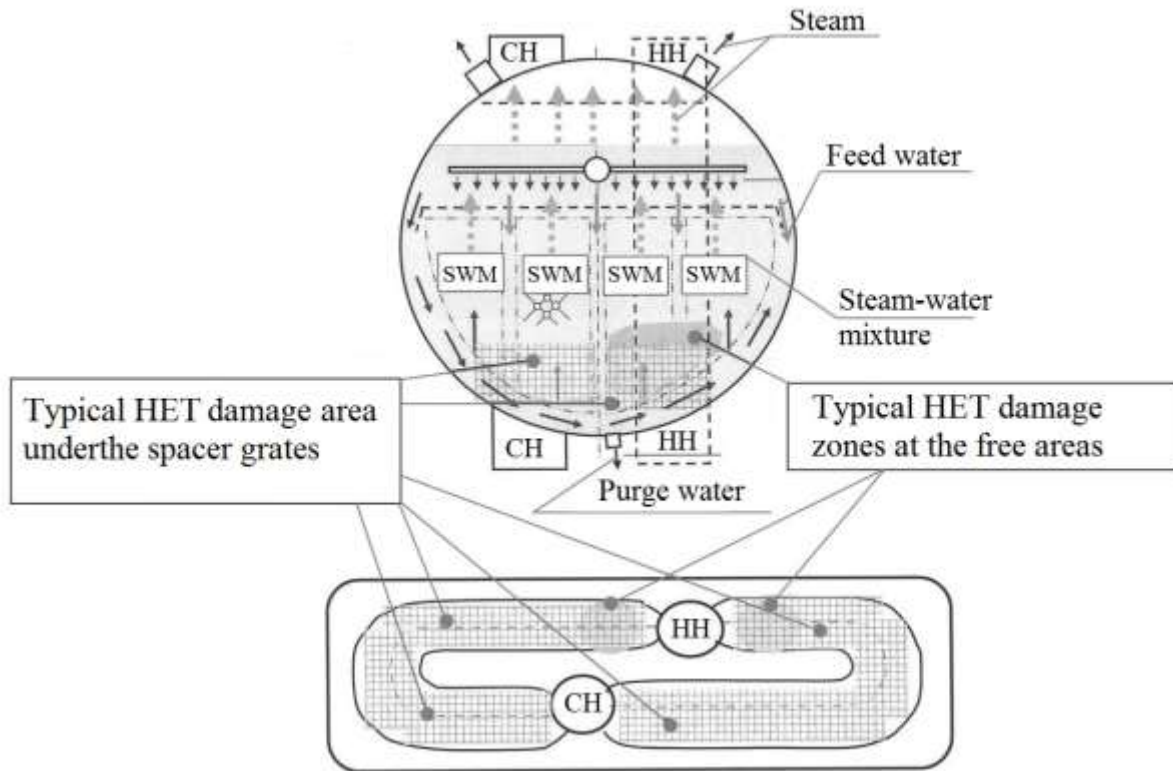
Fig. 1. The steam generator in cross section and plan

The results based on the analysis of HET corrosive defects of the NPP SG with WWER at Ukrainian and foreign NPP are cited in papers [491-494]; it was determined that the corrosion defects on free areas and under spacing elements tend to appear mainly at a bottom of SG tube bundles (Fig. 1) [489].

Whereupon the defects on free areas localize mainly near hot header (HH). The defects under spacing grates are also situated at the SG bottom but distributed more evenly along with the tube bundle.

On the whole, the SG with HET active degradation is characterized by the formation of so-called “critical areas” where the defects are located. This is due to sedimentation of corrosion product of significant thickness up to complete blocking between tubes [489, 491]. The analysis of service data indicates that first systematic HET blank off done based on ECT results are carried out after accumulation on the HET surface of the significant sedimentation of corrosion products with specific contamination equal to 300-400 g/m² [489].

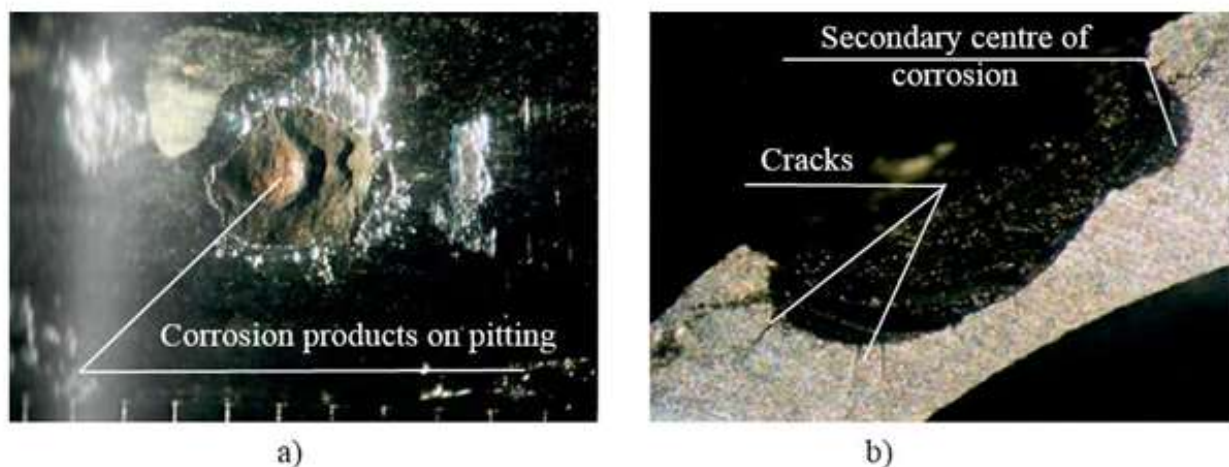
Based on the results of the performed analyses, it was determined that corrosion pitting is the most frequent one to occur. The pitting corrosion is known as the most dangerous type of local corrosion. Corrosion pitting defects were conditionally distributed into critical and subcritical during the test performance. Critical defects are those which make a further HET operation dangerous. The tubes having such defects should be blanked off. From the standpoint of ECT, the critical corrosion pitting is characterized by a great percentage of metal loss (from 60 to 100%) at signal amplitude equal to 10...20 V (Fig. 2) [489]. Characteristic properties of these defects from the metallography standpoint are as follows. In all the analyzed cases these are large corrosion pitting which have round, oval or elongated longwise shape of the tubes. The defects have the dimensions in 2...4 mm range on the tube metal surface. The corrosion products sediments have the intricate shape in the form of coaxial circles positioned around a central hollow – a pitting core. In most cases the cracks are propagated from

corrosion pitting predominately longways the tube surface; the cracks may be up to 20 mm long [489].

Fig. 2. Critical round shape corrosion pitting:

- a) Defect appearance on the HET surface;
- b) Defect appearance on the metallographic section

- avoidance of exceeding the limiting specific contamination at HET by limiting the corrosion product ingress into SG;
- exclusion of copper-bearing alloys from condensation-feeding equipment of NPP with WWER-1000 reaction plant;
- limitation of oxygen access to HET during SG life cycle, observing the conservation rules.
