EMERGENCY CONDITION OF LOGGIAS IN BUILDINGS WITH SUPPORTING BRICK WALLS

All these construction errors, individually or in combination, often lead to damage or destruction of the load-bearing structures of loggias, which, in turn, makes the building an emergency. An example of such a situation is the condition of loggias in an existing building with load-bearing brick walls on the street. Volodymyra Velykoho, 44 in the city of Lviv.

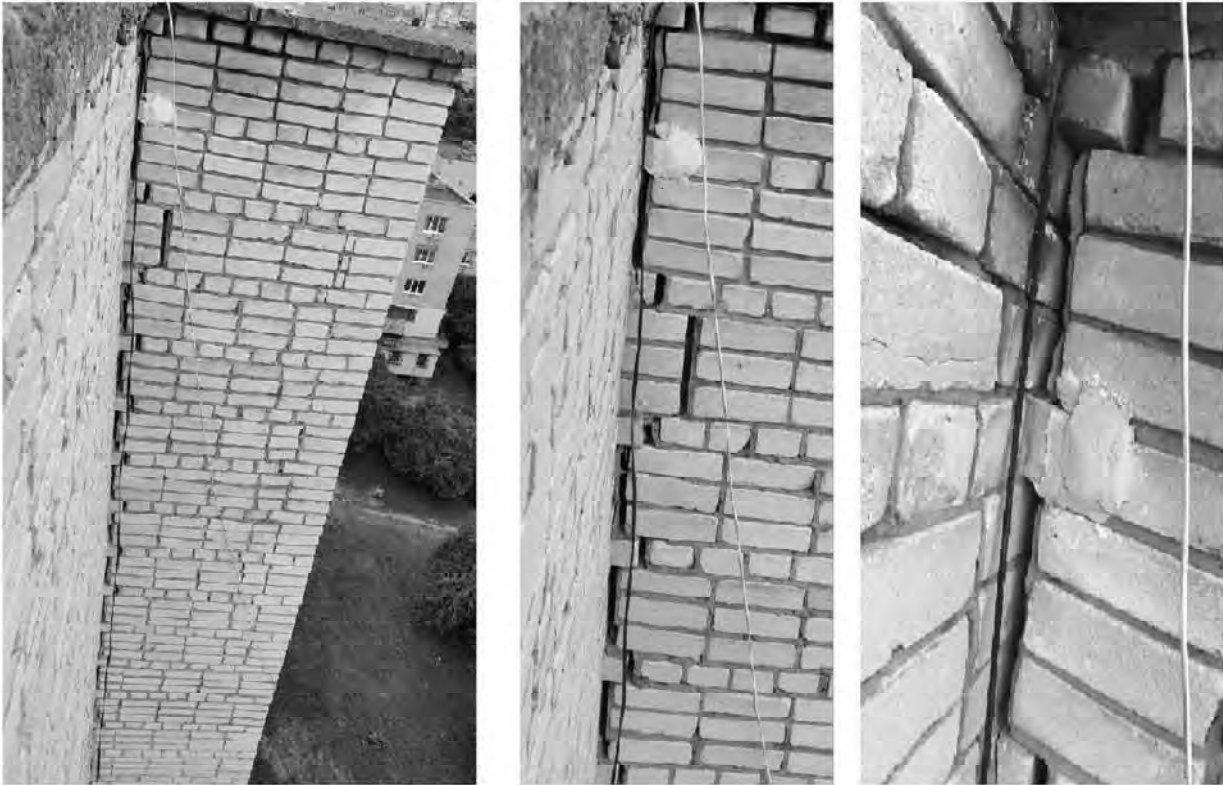
Fig. 2. Vertical crack at the junction of load-bearing walls and loggia

- vertical crack along the height of the building at the junction of the load-bearing walls of the loggia and the house with a width of up to 40 mm;
- poor-quality ligation of brickwork of the longitudinal load-bearing walls of the building with the transverse load-bearing walls of the loggia;
- deviation horizontally from the building of the load-bearing structures of the loggia;
- diagonal crack when making a load-bearing wall of a loggia with a difference of seams to 20 mm (Fig. 4).

In (Fig. 2) you can see a vertical crack in the height of the building, the width of which is greatest at the highest point of the building and reaches 40 mm. The crack is mainly in height between the rows of masonry, but there are also cracks in the body of the brick in a row, which serves as a link between the wall of the loggia and the load-bearing wall of the building.

The brickwork of the loggia is three-row with a bandage in one row, which connects the loggia with the perpendicular load-bearing wall of the house. Prefabricated ribbed reinforced concrete floor slabs rest on the end bearing load-bearing brick walls of the loggia and are not attached to the building. This means that the connection of the loggia with the house is solved by only one row of masonry, which is nested in height in three rows.

After the formation of a through crack at the height of the building, the loggia begins to work as a free-standing part, respectively, there is a danger of its destruction.

Based on a visual inspection of the visible part of the building structures and the results of calculations, it can be concluded that the cause of cracks is poor quality masonry load-bearing walls of the loggia and load-bearing walls of the building, which caused an emergency condition of the building.

This situation requires fencing of the area near the loggia, a ban on residents to go to the loggia and the urgent development of a project to strengthen building structures to eliminate the emergency situation.

Reinforcement of the considered building structures can be made of metal structures, namely clamps and straps, which should connect the structure of the loggia with the load-bearing wall of the

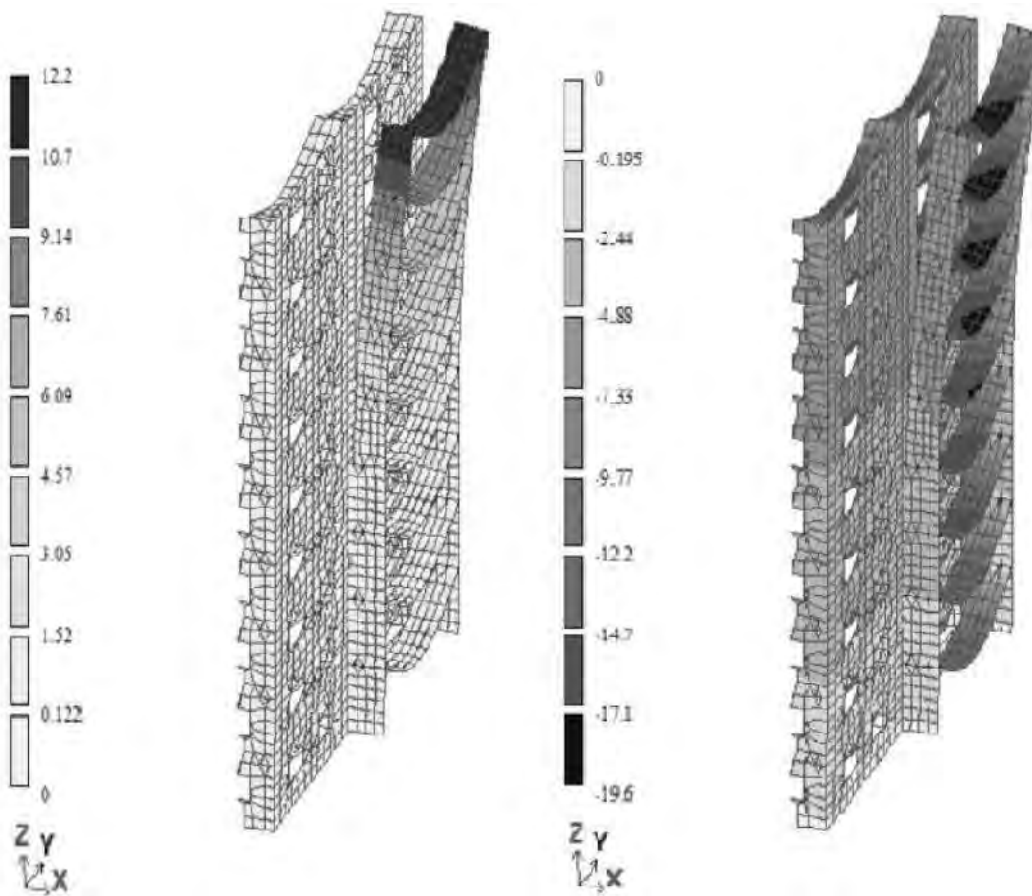
Fig. 3. Isopolies of loggia displacements along X (horizontal component, mm) and Z (vertical component, mm)

To better understand the operation of the structure after the formation of cracks and taking into account its structural scheme and white loading, a calculated finite element model was created in the PC "LIRA-CAD" and the movement of the loggia was obtained (Fig. 3).

The structure of the loggia is designed so that the loads are unevenly distributed, namely on the outside (from the side of the facade) enclosing reinforced concrete panels and glazing create a running load, which causes skew of the loggia structure, because it is not attached to the building properly.

To obtain a more accurate reproduction of the existing structure of the loggia, after the formation of through cracks, in the calculation scheme between the outer load-bearing wall of the building and the 5 upper floors was modeled deformation seam (at this height visually visible crack opening).

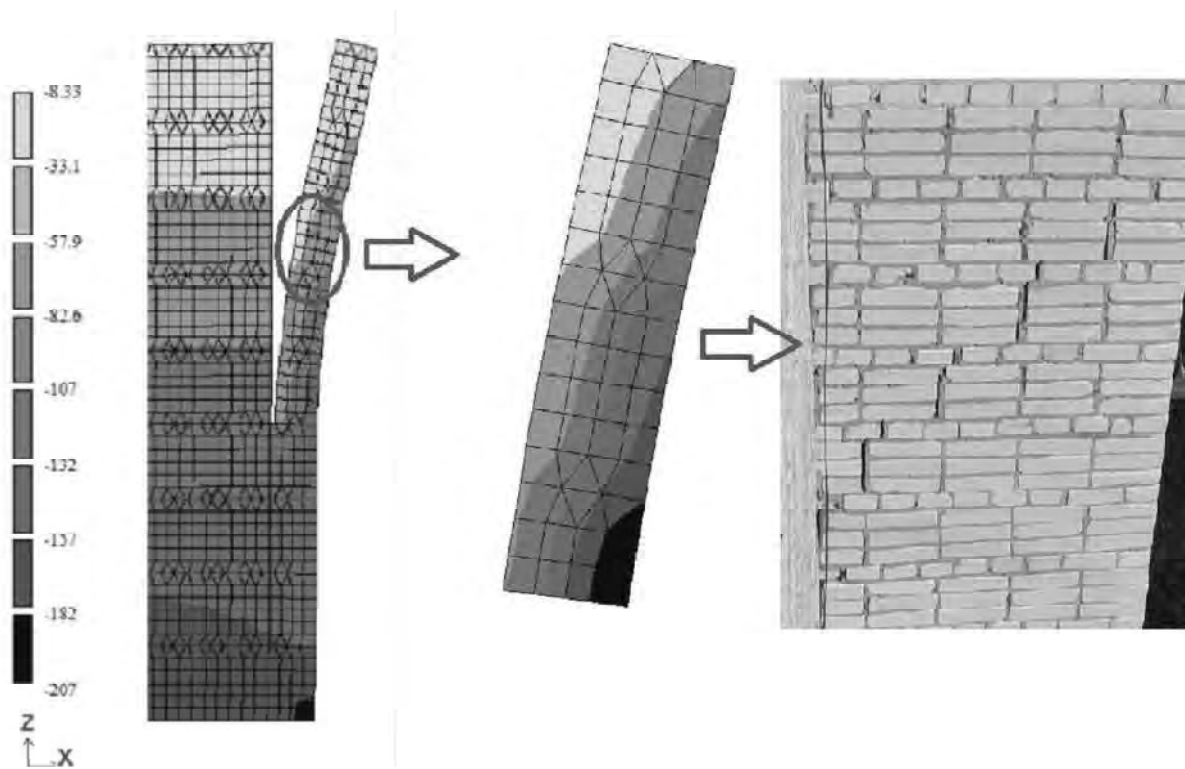
Fig. 4. Comparison of stress distribution N_y with a diagonal crack

A diagonal crack, which is located at the level of the 6th floor, is also fixed in the end bearing wall of the loggia (Fig. 4). The reason for this crack is that after the connection between the walls of the loggia and the walls of the house collapsed, the loggia began to deviate from the building, due to the fact that the facade of the loggia has constant running loads from reinforcing concrete wall panels and glazing.

(Fig. 4) shows the distribution of vertical stresses N_y , as well as the diagonal crack that cuts the brickwork at the seams.

External loads are applied to the facade of the loggia, which, in turn, due to the occurrence of a through vertical crack, leads to uneven stress distribution.

According to the comparison, the nature of the stress distribution corresponds to the nature of the development of the diagonal crack.
