Sofia Pinchuk, Svetlana Gubenko and Elena Belaya

## CORRELATION BETWEEN ELECTROCHEMICAL CORROSION AND STRUCTURAL STATE OF STEEL BY SIMULATION OF OPERATION CONDITIONS OF RAILWAY WHEELS

National Metallurgical Academy of Ukraine, 4, Gagarin ave.,  
Dnepropetrovsk-5, 49600, Ukraine  
belaya\_alena@mail.ru

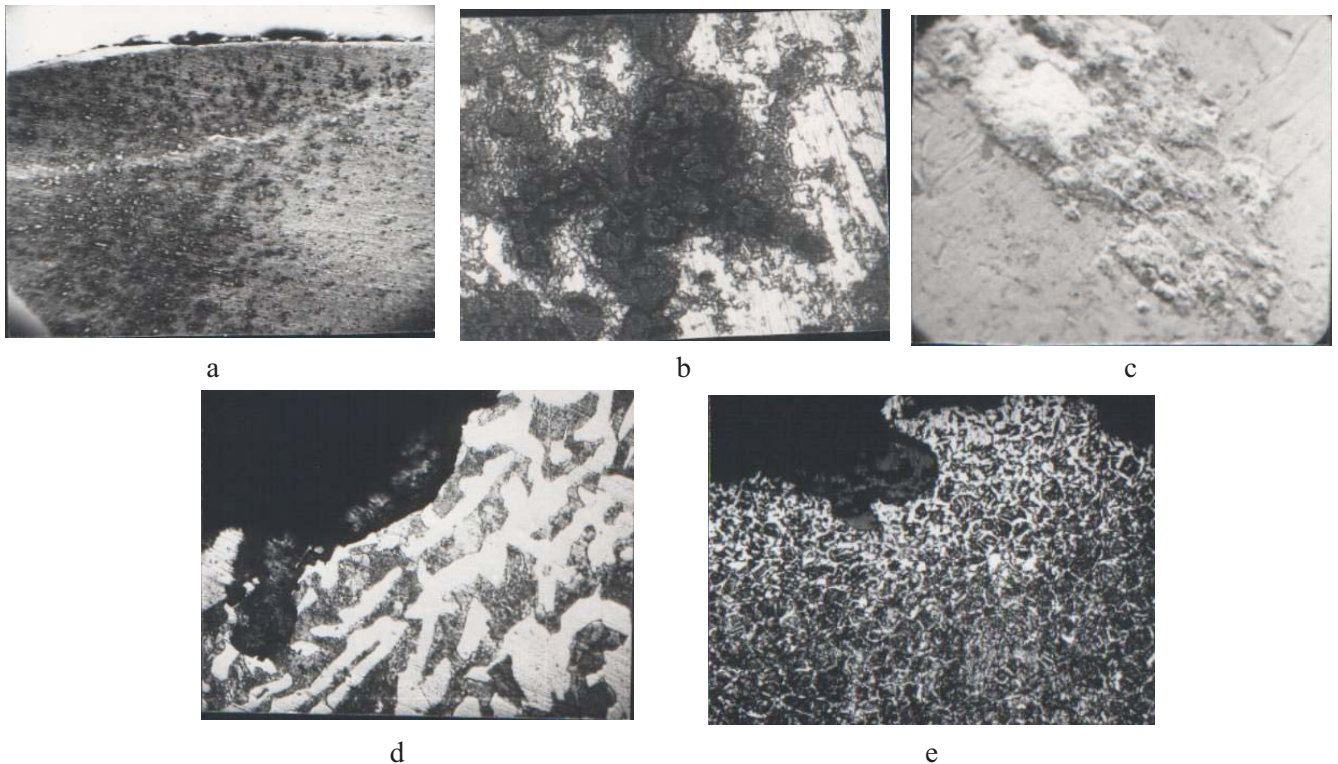
Fig. 1. Sections of corrosion in railway wheels 1 and 3: macro (a), x500 (b–d) and x200 (e)

Oxidation of steel takes place at all parts of wheel – tread, disk, and hub. Oxides particles are determined by metallographic research (Figs. 1a–d). Oxidation of steel starts from the surface and penetrates into inner layers at a considerable depth. Thus long operation of railway wheels allows to see the sufficiently large sections of corrosion. Investigation of non-operated wheel 3 allows to see small sections of corrosion in wheel’s different parts (Fig. 1e). These zones are ready centers of corrosion damage during operation of railway wheels.

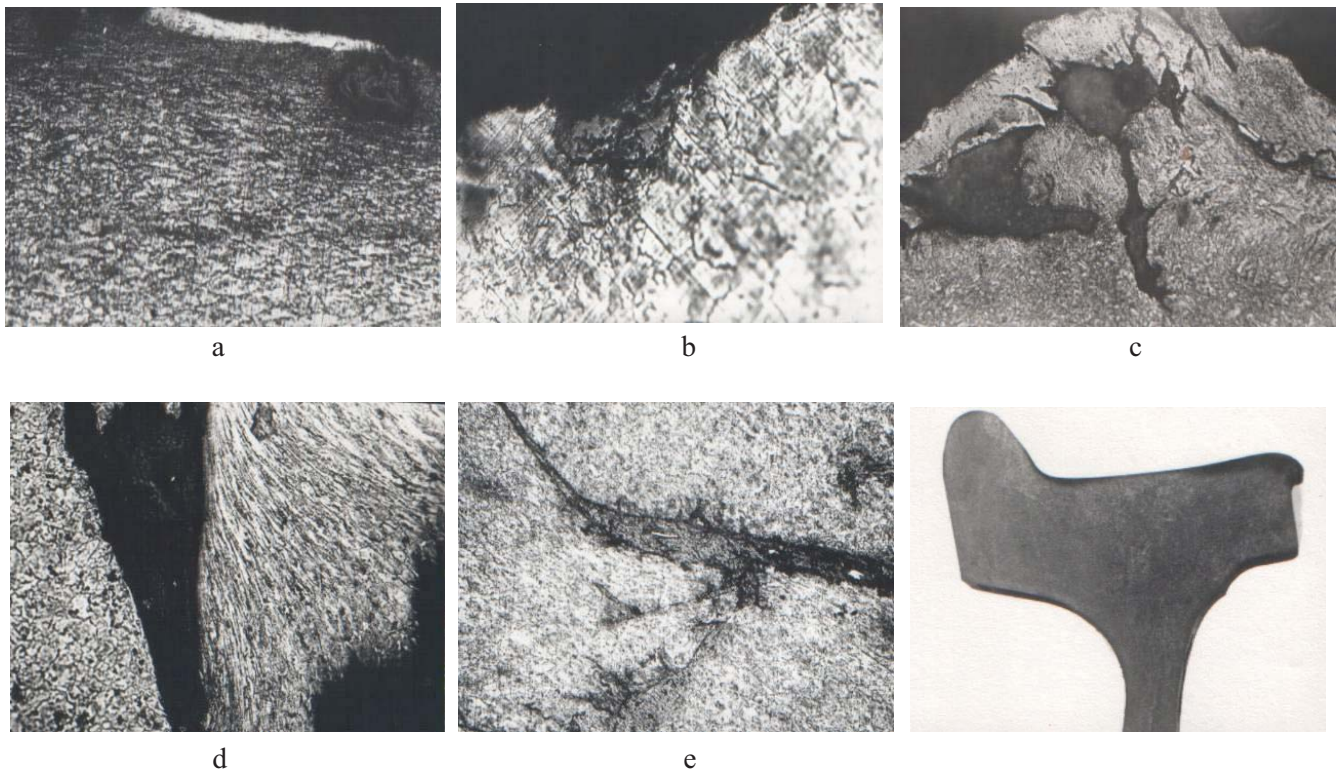
**Fig. 2.** Sections of corrosion near tread of railway wheel 1 after operation: x500

The microstructure of wheel rim near tread is characterized by the presence of deformed grains zone and sections of “white layer” (Fig. 2) [2]. The depth of the “white layer” is 20–40  $\mu\text{m}$ ; it has intermittent character owing to the crumbling during railway wheel operation. In cavetto zone of wheel 1 the steel grains are considerably elongated and grinded (Fig. 2a), but at the egress to tread the grains are bigger, degree of their elongation decreases and they have the least value in the middle of tread (Fig. 2b). While moving from the middle of tread to the rim border the degree of grain elongation increases again. The character of steel structure in this part of tread indicates the considerable flow of steel resulting in the change of railway wheel profile [2]. In roll zone there are breakings oriented in parallel to tread. One can see from Fig. 2c that cracks spread from these breakings. As a rule cracks are on the boundary between areas with different microstructure of steel and divide zones of elongated and equiaxed grains. The roll takes place gradually, by layers, which are distorted during their shifting. At the same time brittle cracks promoting metal fracture in the layers appear. At the edge of roll the lobes with strong deformed structure (Fig. 2d) overhang on the rim side. They also indicate a lamellar mechanism of metal roll. Cracks are obvious between mentioned layers and between rolled metal and rim side. Turbulent flow of metal layers in roll zone is discovered during investigations of steel structure in the plane parallel to tread (Fig. 2e).

Analyses of metallographic investigations allows to assert that structural changes occurred near tread of railway wheel are accompanied by corrosion. Zones of corrosion damage are detected along rim section in areas with strongly deformed structure as well as in the “white layer” areas (Fig. 2a). At the roll formation on the rim side, when thin layers of steel transfer from the middle of tread to the rim border and overlap, the areas with oxidated surface of steel are in internal parts of rim (Fig. 2c and 2d) and between layers of deformed metal (Fig. 2e). Evidently, the presence of large oxide particles results not only in local fractures of tread but also in heterogeneous development of structural changes in thin layer of metal.

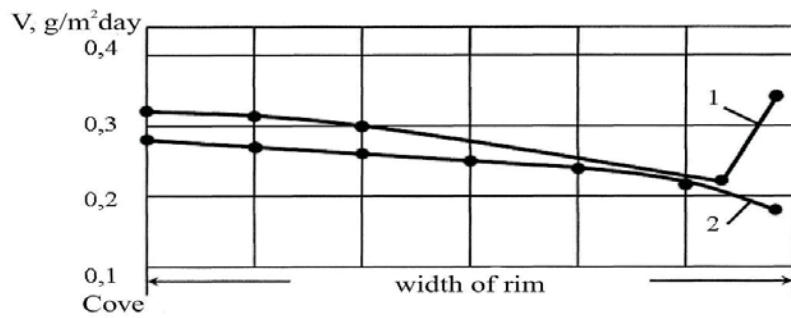
Fig. 3. Change of corrosion rate  $V$  of wheel steel specimens from tread along rim width of wheels 1 and 2

from worn wheels 1 and 2 were tested for corrosion. Specimens from wheels 1 corrode with different rate which decreases from cavetto zone along rim width and increases only near the end of tread in the roll zone (Fig. 3, curve 1). Thin parts of “white layer” corrode very quickly and are not detected in the steel structure.

Specimens from worn wheel 2 also corrode with different rate, which monotonically decreases from the cavetto zone along rim width (Fig. 3, curve 2). “White layer” corrodes *via* pitting corrosion practically to the all depth (Fig. 5a). In the areas with primary structure of steel (pearlite + ferrite) and small zones of “white layer” the corrosion begins on the surface centers of attack and penetrates deep into steel as cracks (Fig. 5d) or as compact front (Fig 5c). Microcracks penetrate from the corrosion areas, mainly along the boundaries of ferrite-pearlite and pearlite, which has well-developed interphase ferrite-cementite boundaries (Fig. 5d).

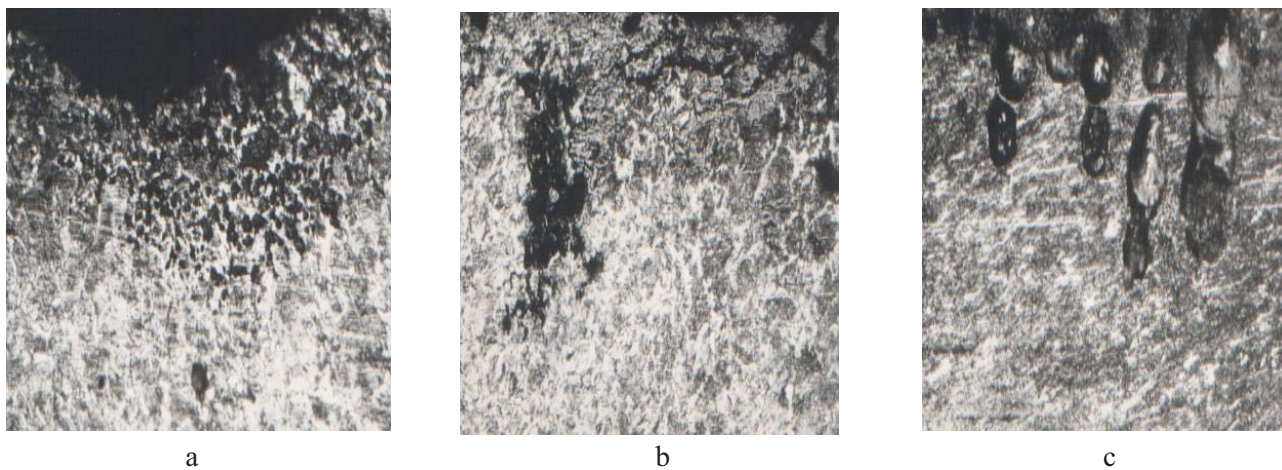
Fig. 4. Microstructure of wheel steel (wheel 1) after corrosion tests in different parts of tread along rim width: x200

The change of corrosion rate and mechanism is obviously connected with the change of plastic shear zone character. In the cavetto zone where grains are elongated the corrosion rate is maximum. A lot of small (< 20 mcm) oval localized centers of hot-spot corrosion are detected (Fig. 4a), which penetrate to considerable depth. Maximum corrosion rate in the cavetto zone is explained by the influence of plastic deformation creating stresses in metal. In the middle of tread the corrosion character varies (Fig.

4b). Corrosion friable film with microcracks is formed over specimen surface. Corrosion rate of specimens from the middle of tread toward side of rim decreases to the minimum and increases only in the roll zone (Fig. 3, curve 1). Hot-spot corrosion appears again (Fig. 4c). Average size of corrosion centers is 0.6 mm. Increase of corrosion rate in the roll zone is explained by the influence of considerable plastic deformation and also by the presence of cracks between layers of rolled metal. Corrosion centers in the roll zone are considerably larger than in the cavetto zone. Thus heterogeneous plastic deformation along rim width, which takes place during operation of railway wheels, promotes the heterogeneous corrosion fracture of tread.

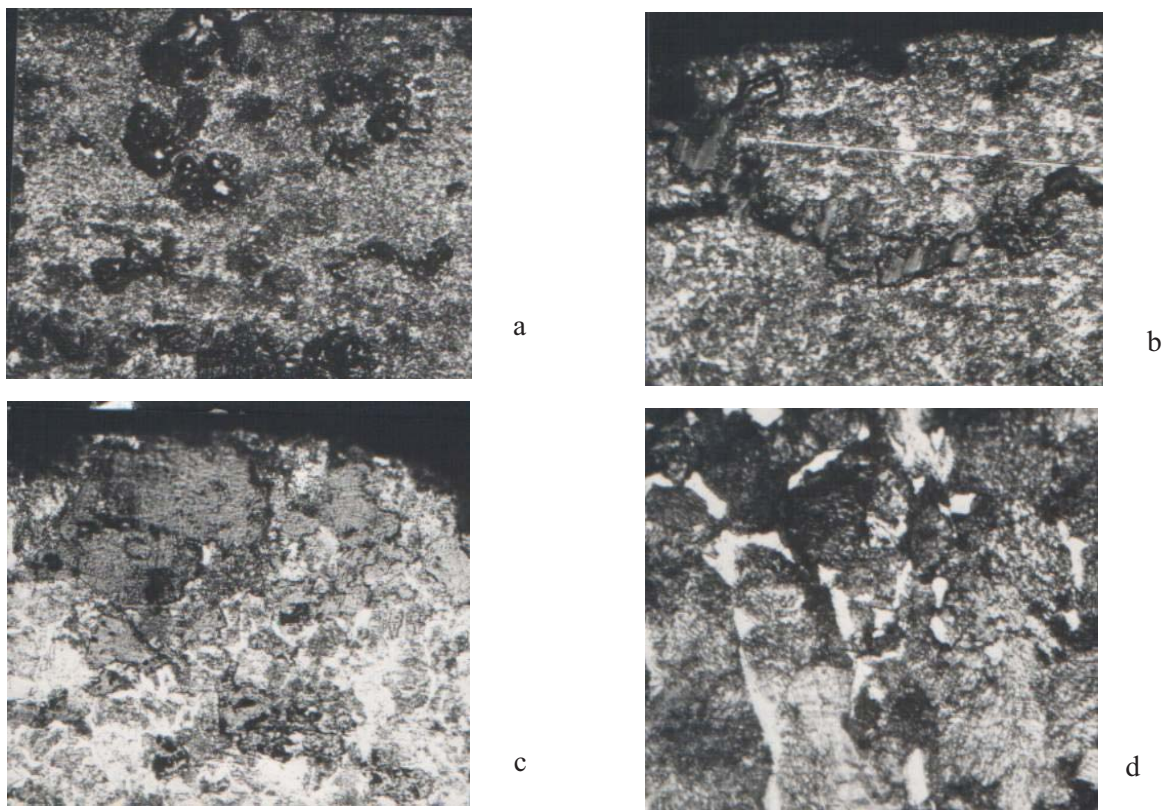
Fig. 5. Microstructure of wheel steel (wheel 2) after corrosion tests in different parts of tread along rim width: x400

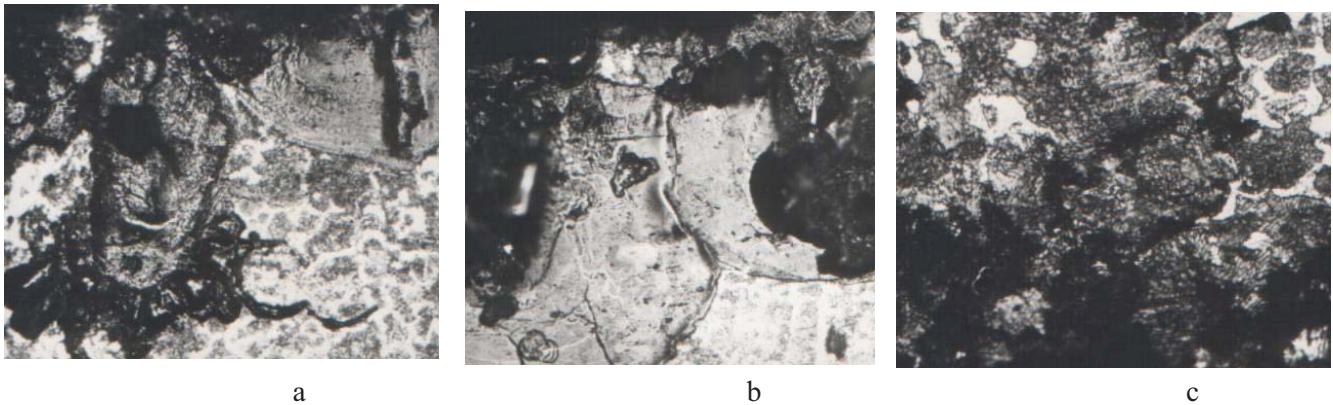
Fig. 6. Microstructure of specimens from the central part of rims of wheel 1 (a) and 2 (b) and from disk of wheel 2 (c): x400 (a-c) and x200 (d)

Corrosion of specimens from the central part of rims of wheels 1 and 2 takes place *via* formation of steel large oxidated centers (Figs. 6a and 6b). Corrosion centers are formed on the specimens surface and then penetrate into the depth of specimens widening till they contact with each other. At the same time structural and phase stresses originate in oxides and on the oxide-steel boundaries resulting in microcracks appearance. Sizes of corrosion centers in this case are sufficiently great (1–2 mm). Corrosion rate of metal rim having ferrite-pearlite structure for wheels 1 and 2 is approximately the same but higher than that of steel from tread (Table 2).

Metal of wheel disk corrodes more quickly than metal of rim central part (Table 2). Corrosion process spreads mainly along pearlite areas (Fig. 6c), as well as along ferrite-pearlite boundaries. Corrosion mechanism for rim and disk metals is different: large corrosion centers are present in the rim inside areas and a lot of small corrosion centers are situated in the surface layer of the disc. From corrosion centers intercrystalline cracks spread along pearlite and ferrite-pearlite boundaries. Corrosion rate of specimens from disk of wheel 1 is slightly higher than that of wheel 2.

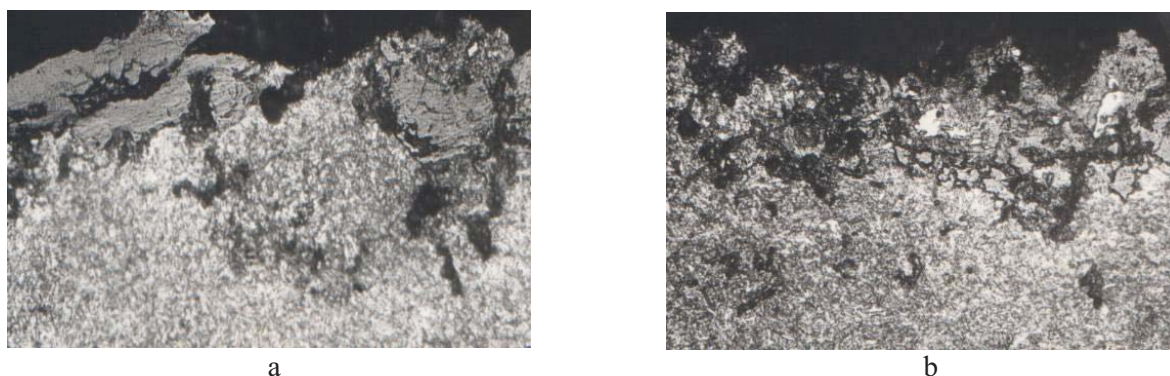
Corrosion of specimens from tread of heat treated wheels 3 and 4 (with addition of vanadium), having secondary sorbite structure, has lamellar or film character. Specimens from rim central part of wheels 3 and 4 have the same character of corrosion (Figs. 7a and 7b). Brittle cracks spread from friable oxides to steel. Steel with vanadium additives corrodes more quickly than ordinary wheel steel (Table 2). It is known that vanadium as well as manganese [1] promotes the decrease of steel corrosion resistance. The tread after heat treatment corrodes more quickly than tread after operation. Corrosion of specimens from the rim central part of wheels 3 and 4 has pitting character with cracks distributed along pearlite.

In heat treated railway wheels tread corrodes more slowly than metal from the rim central part. It is connected with more dispersed ferrite-pearlite structure of tread after heat treatment. Microaddition of vanadium accelerates corrosion of tread and rim central part.

**Fig. 7.** Surface microstructure of specimens for wheel steel with vanadium additives (a) and ordinary wheel steel (b) after corrosion tests: x200

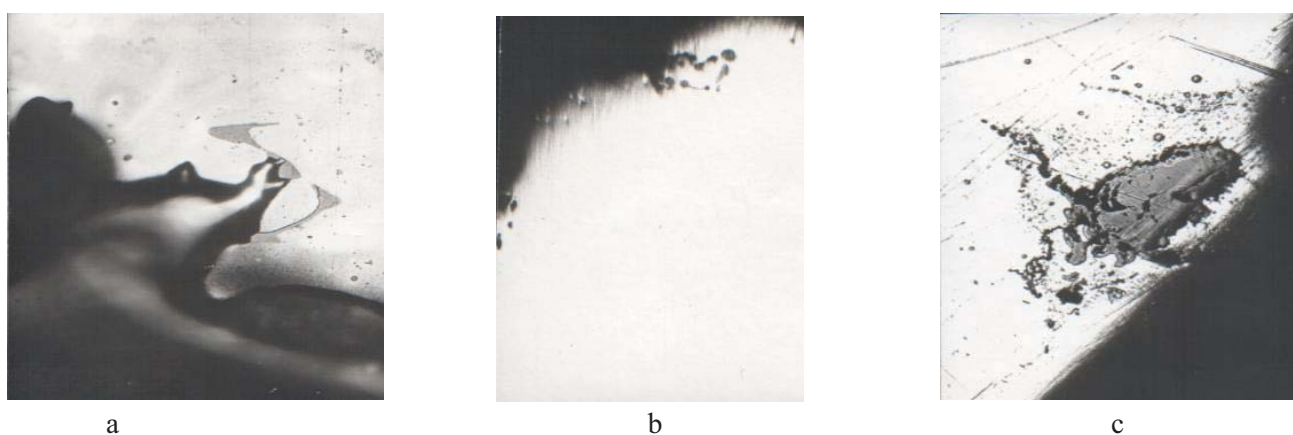
**Fig. 8.** Corrosion fracture of wheel steel near non-metallic inclusions: sulphide (Fe, Mn)S, tread of wheel 1(a); sulphide (Fe, Mn)S, rim of wheel 2 (b) and oxide  $MnO \cdot Al_2O_3$ , tread of wheel 1 (c); x600

It is known that considerable thermal and deformational stresses caused by different physical-mechanical properties of non-metallic inclusions and steel matrix appear near these particles [4]. Stresses occur at the different stages of railway wheels production. Concentration of stresses promotes the corrosion damage for all kinds of non-metallic inclusions. Especially it is obvious for external stresses. In our researches the nucleation and localization of corrosion fracture of wheel steel are observed near different kinds of non-metallic inclusions in both worn and heat treated railway wheels (Fig. 8).

Thus, a metallurgical factor, namely contamination of wheel steel by non-metallic inclusions, is a very important factor in the problem of corrosion fracture of railway wheels.
