**Vol. 1, No. 2, 2015**

## **THE PALACE AND GARDEN COMPLEX IN WŁODOWICE. PROSPECTS FOR RESTORATION AGAINST OTHER TOURIST ATTRACTIONS OF THE KRAKOW-CZESTOCHOWA JURA**

**Abstract.** The article analyses potential restoration of a historic park and palace complex in Włodowice. It discusses the pragmatics of preservation in conservation practice. Furthermore, the author suggests possible courses of action designed to bring clarity to the original layout of the complex and popularize the commune as a tourist attraction.

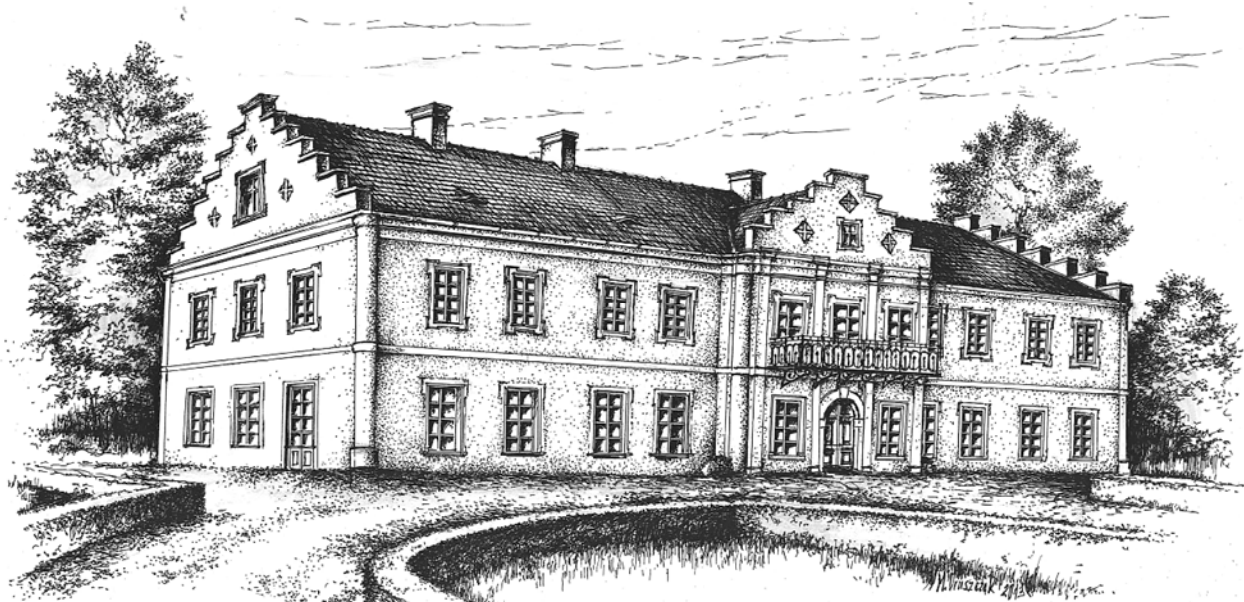
Fig 1. Drawing of the palace

The palace is in the form of ruins with preserved front wall and several rooms on the ground floor. They are all completely demolished, flooded by water and covered with vegetation, which is a serious threat to the ruins. Roots are disintegrating uncovered walls, deteriorating their condition. The fires have completely destroyed wood elements. What can be only seen now are the places they were originally embedded. Out of the four chimneys, two have survived to this day but their top parts have fallen apart. Cast-iron railing on the front wall of the building is the last surviving trace of the old balcony.
