STRENGTHENING OF THE REINFORCED CONCRETE TANK AFTER FAILURE

The paper describe an interesting case of rectangular reinforced concrete tank strengthening. Due to errors in reinforcement design, the long walls of the tank were seriously cracked and starts to leak during the water test. As alternative to total tank demolition, a simple and effective strengthening method was developed and applied. Because the basic defects occurred in long walls of structure, the tie system was designed and constructed. The group of precisely located bar ties anchored on the strengthened walls outer surfaces reduced the stresses in these walls to the level, which could be carried by structure with existing reinforcement. The ties and their anchorages were made of stainless steel, and during design special attention was paid to actual technical state of the tank structure and its environmental conditions. The successful strengthening allow the tank to start the operation with only small time delay and any problems actually noticed.

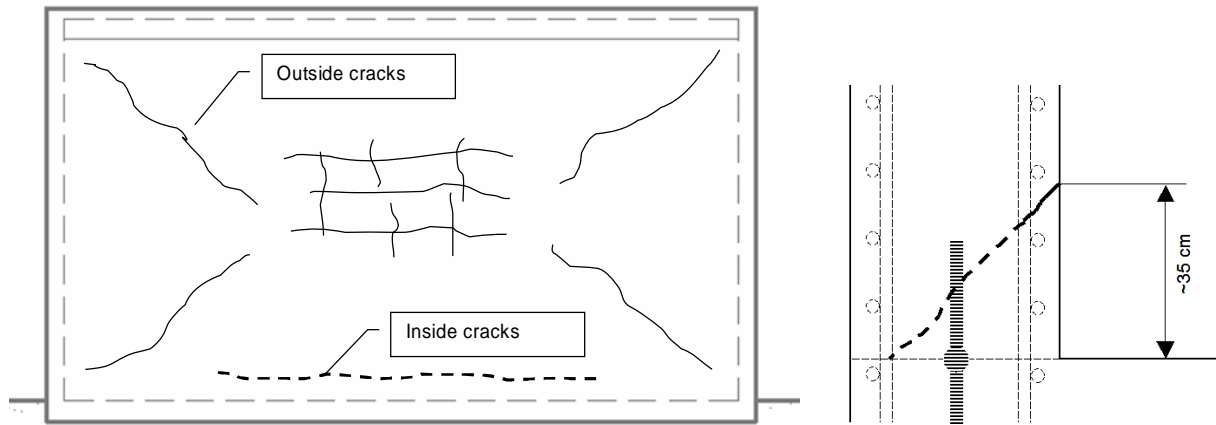
Fig. 3. Left: sketch of outside cracking. Right: probable progress of the inside crack

The test was immediately stopped and the tank was emptied. The review of the structure shows characteristic crack pattern on both long side walls area. Additionally, there was a single horizontal crack noticed along the long walls located 30 cm above foundation raft.

The failure analysis. Observed cracking is typical for overload of the tank structure, particularly for the longside wall panels. The cracking distribution is characteristic for yield line mechanism of failure of slab supported on all edges [1].

According to typical behavior under increasing hydraulic inside pressure, the initial yielding started on bottom edges (inside, horizontal crack), and spread through the slab as moments were redistributed from yielded regions to areas that still remain elastic (panel span), yielding them at least (outside “envelope” cracking).

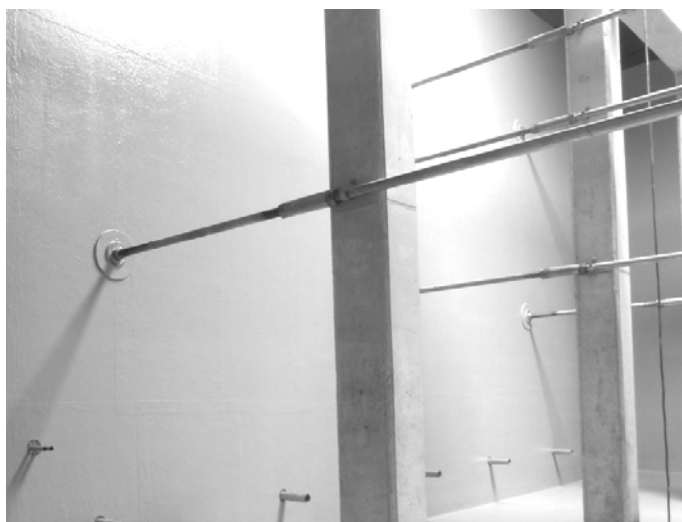
Fig. 6. Tie-bars installed and supported on the inner columns

Basic assumption for tying. The tie-bars run perpendicularly to the long walls planes, and passing through the drilled holes in walls are anchored outside. Because the sewage pressure acts identically to the opposite walls of the tank, so the ties give no unbalance effect on the walls, to which will be attached. For temporary support during installation and further tank maintenance operations, tie-bars were supported on the columns of the inner RC frame.
