## REPRODUCTION OF THE LOST MONASTIC COMPLEXES OF OSBM

**Abstract.** The degree of the Basilian monastic complexes preservation in general and each object in particular is being investigated and the possibilities of their reproduction with adaptation to the original function are determined in the article.

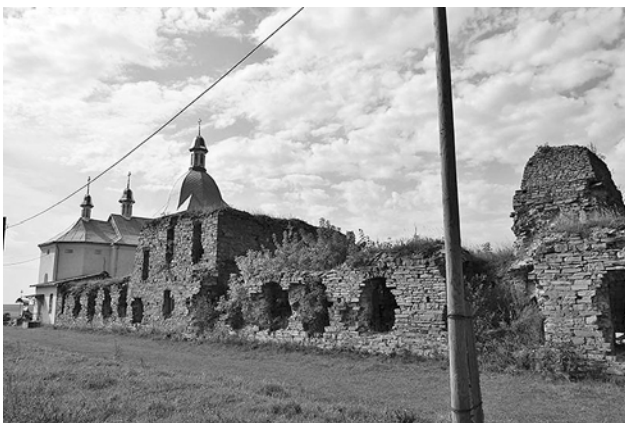
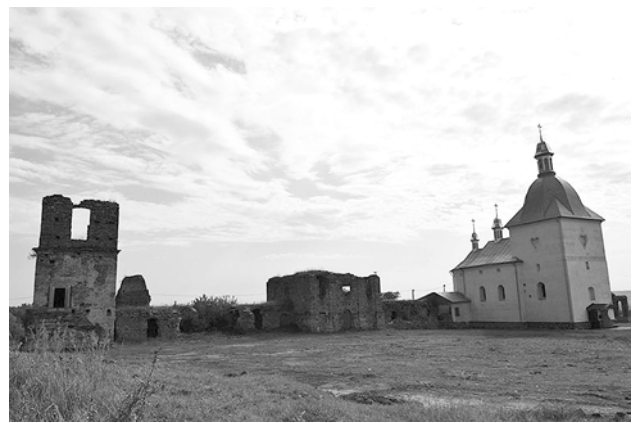
**Fig. 1.** Transfiguration Monastery in Pidhora village.  
Photo 2017

**Fig. 2.** Transfiguration Monastery in Pidhora village.  
Photo 2017

An important place in the historical and cultural heritage belongs to the defensive monasteries-fortresses with centuries-old history, connected with the historical past of the region, ranging from the Mongol-Tatar invasion to the Tatar incursions. These monuments include a defensive monastic complex in the village. Pidgoryany on the outskirts of the city of Terebovlya, founded in the 16<sup>th</sup> – beg. 17<sup>th</sup> [2], but now, it presents only the ruins remained (Fig. 1, 2). The monastery is located on a high mountain hill where the rivers Gnisna and Seret are merged. The monastery-fort in plan is shaped like a trapezium, surrounded by the high stone walls with four corners of the two corners of the two-tiered cylindrical tower. In the middle of the northern defense wall there is an entrance gate along the axis which, in the depths of the monastery's yard, is a three-storey masonry, defensive church of the Transfiguration of the Lord, which from the north is adjoined to an elongated monastic complex with the cells, a refectory, a library, a kitchen and other premises. This building on the northern end adjoined to the premises at the gate, forming a G-shaped plan. Two of the four corner towers have been preserved – south-west and north-east ones. Nowadays, only the monastery church has been restored. In the restoration process of the monastic complex it is necessary to apply conservation, fragmentary and integral restoration, in order to maximize the preservation of the monument [3].

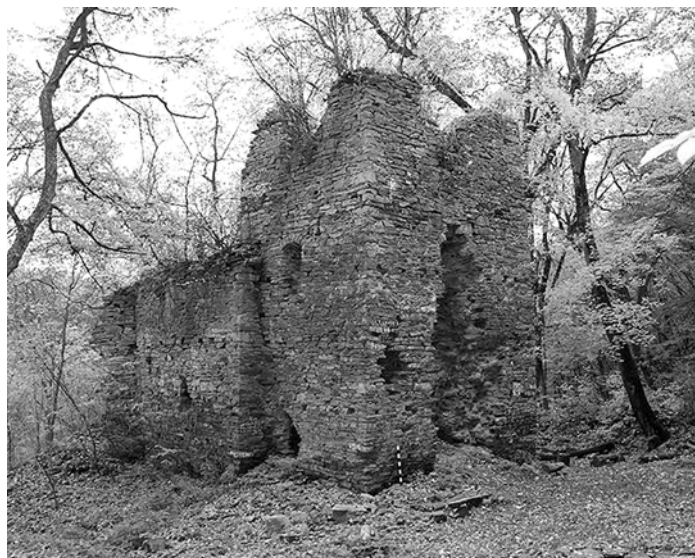
**Fig. 3.** The church's ruins in the tract Monastirok.  
Photo 2014

The monastic church in the tract Monastirok, which is 2 km to the south of Buchach, is located on a rocky hill on the right bank of the Stripa River, has also survived to this day only in ruins (Fig. 3,4). The massive walls with the thickness of 1,7–1,8 m testifies of their defensive character. The temple is three konh with a rectangular porch and a high tower-bell tower over it. The height of the walls of nave and konh reaches 9

meters. The eastern part of the temple was completed by the apse conch, the two smaller conches emerged from the southern and northern walls of the church. The width of the apse is approximately equal to the nave width. Two narrow, high windows with semicircular jumper cut through the southern wall and one round window cut through the southern konh. The apse and the northern wall of Navi and the northern conch are without windows. Such construction of the northern facade was apparently due to the defensive needs – the northern wall of the church was turned towards the monastery gate, from where the enemy was expected to attack. The western facade of the temple completed a square in the plan tower-bell. The main defensive function was performed by a tower, approximately 15 m high, in the western wall of which was the entrance of the temple. Above the entrance there were two battle tiers, with one loophole on each side of the tower. A staircase, arranged in the thickness of the stone wall of the tower provided the connection between the tiers. Till now, only the church has gone to ruins. Such type of monuments is one of extremely rare in Ukraine. This monastery temple is of historical and artistic value and prompts the need for restoration measures to preserve it.

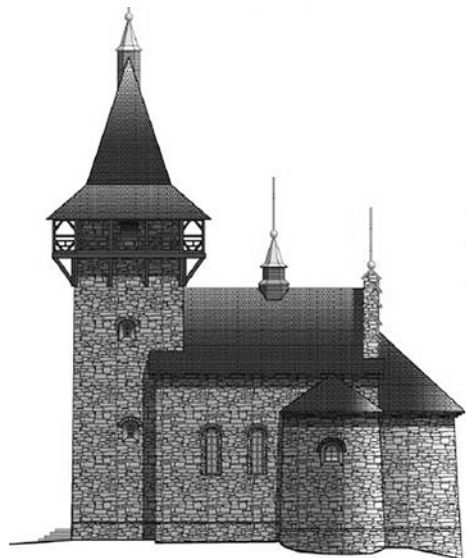
**Fig. 4.** Hypothetical reconstruction of the church  
in the tract Monastirok

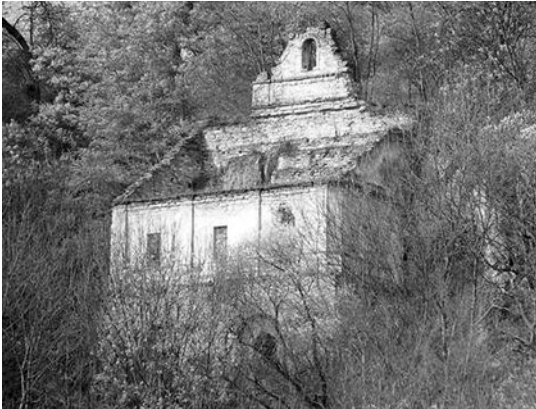
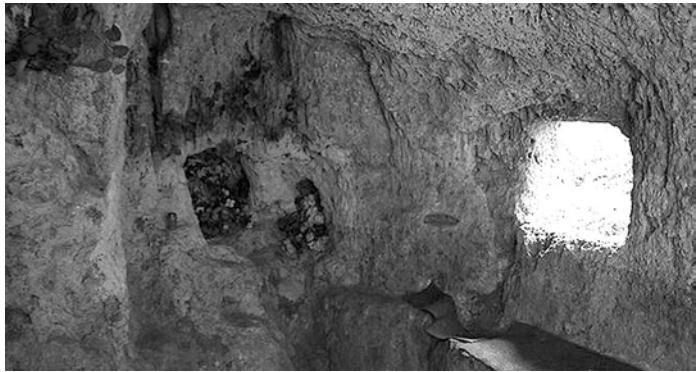
**Fig. 5.** Ruins of the monastery cave churches in Ulashkivtsi. Photo 2014

**Fig. 6.** Ruins of the monastery cave-cell churches in Ulashkivtsi. Photo 2014

The new masonry monastery complex was built somewhat higher on a plain natural terrace in 1898 [7]. The ruins of the monastery cave church and the cell under it have survived to this day (Fig. 5, 6). To get to the monastic cave cells one has to climb the steep slopes. The monastery was located on the two levels. On the first tier of the caves there is a small cell with a window where the monks lived, overlooking the river Seret and the surrounding villages. The only entrance is covered due to the collapse. The church of Ivan the Baptist is added to the cliff. The cell located on the second tier, was really hard to get, as one need go down six meters deep into the cave with the help of the chain built by the local inhabitants. The cave monastery is belonged to those unique monuments which require an urgent systematic survey of open monastic objects, instrumental cave surveys and archaeological research, hence, any restoration measures for the preservation and restoration of the monuments have to be based on these investigations. We propose the following measures:
