## THE INFLUENCE OF LONG TERM DYNAMIC AND VIBRATORY LOADS ON BEARING STRUCTURES OF THE AMMONIA REFRIGERATING SYSTEM BUILDING

To get more information we stop on constructive and planning schemes of the ARS building. The building of Ammonia Refrigerating System is situated on the territory of pharmaceutical enterprises in Lviv (Ukraine). The building was projected in 1982 and was built in 1984. The purpose of the building is pharmaceutical production. The category of firefighting building is "B". The class of explosive danger is "B-16". The major repairs have not been carried out for all the time of exploitation except repairing of soft roof and walls reinforcement by using armature levers.

ARS is one-storey brick building of axis "1"... "1/1" and "2"... "3", two-storey building of axis "1/1" and "2", without cellar, rectangular in plan, 6.5 x 22.15 m. in size (Fig. 1 and Fig. 2).

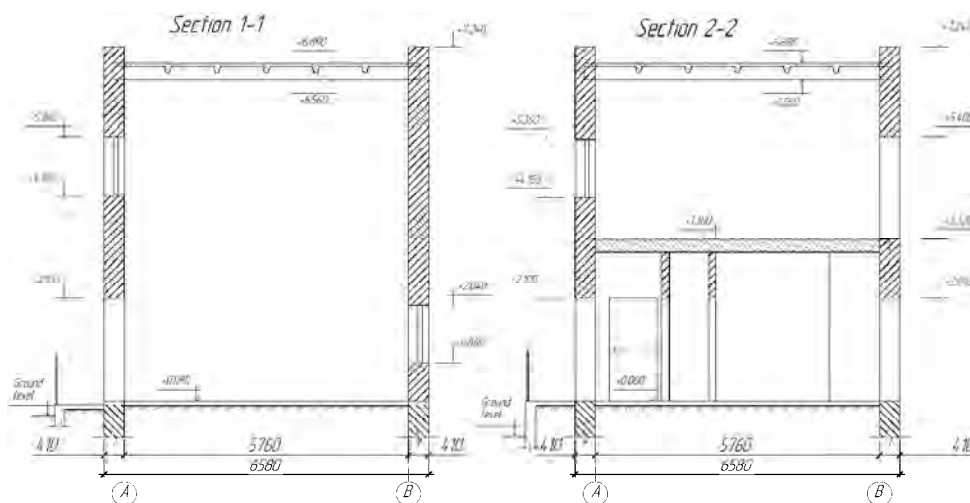
Fig. 2. Sections 1-1, 2-2

The height of one-storey ARS brick building to the lower part of bearing structures of coating is 6.3 m, the height of every floor of two-storey building of axis “1/1” and “2” is 3.3 m. The building of Ammonia Refrigerating System is the separate technological construction that is not connected with the other constructions of the factory. The structural scheme of the brick part of building consists of longitudinal bearing walls (axis “A” and “B”) and transverse self-supporting walls (axis “1”, “1/1”, “2”, “3”). The beams for the pendant crane with load carrying capacity of 2 t. are mounted in the engine room of axis “2”...“3”. The basements under the brick walls are strips, made of prefabricated concrete blocks. Engineering geological researches were made to carry out the necessary strengthening of the building and measurements of the basements were determined in the open pits. The second floor prefabricated reinforced concrete slabs with the round cavities on the mark of 3.300 of ARS brick building are 6000 mm in length and 220 mm in height. The prefabricated reinforced concrete ribbed slabs serve as coating of the building of axis “1”...“3” that are 6000 mm in length and 220 mm in height. Such reinforced concrete coating provides the stiffness of the building along and across. The brick walls are 380 and 250 mm in size and are made from lime and cement. The exterior walls of axis “1”...“3” are made from the red clay bricks and the facing layers by thickness of 120 mm are made from silicate bricks. All coverings are also made from bricks by thickness of 120 mm. The brick building has double slope roof with the inner drain through one drain funnel.

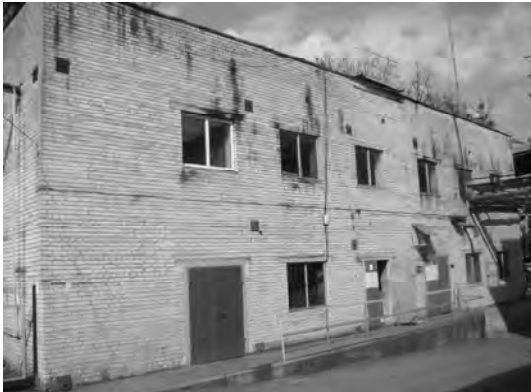
**Presentation of the main material. The investigation of the building structures and damaging of ARS under the influence of long term dynamic and vibratory loads.** The basements and walls suffered the most of the damage of the low-quality constructions, bad exploitation and long term dynamic and vibratory influences. All of these factors led to an emergency. Let's dwell in detail on the survey of basements and walls and point to the main damages and reasons of formation [10–13]. We also focus on the previous investigations and reinforcement of bearing structures from the influence of vibration loads, which didn't give the desirable results (photo 1).

*Photo 1. The main facade of the building ARS of axis "1" ... "3"*

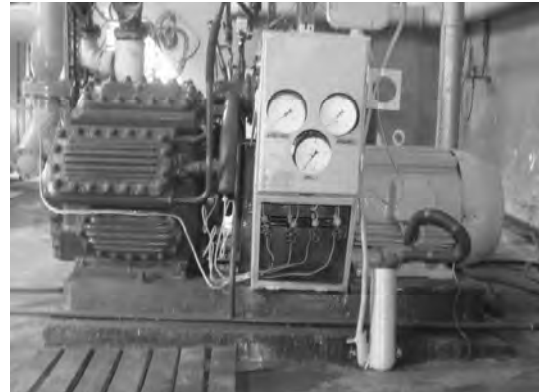
Compressors located in the engine room (axis “2”...“3”, “1”...“1/1” “A”...“B”, photo 2) create a permanent dynamic impact and vibration on the basements.

The absence of deformation seam between concrete floor of the engine room and foundations of compressors create even more influence of the vibration. The deformation seam is also absent between concrete floor and the walls of the building. In 2008 the walls were reinforced with the help of a system of gravity. The armature Ø 28 class A240 was installed in three levels of wall height by the contour of the building [6–8].

*Photo 2. Equipment (compressors) that create vibration and dynamic loads on the building*

3. to arrange a new construction of the floor in the building with compressors, to provide the deformation seams between concrete floor and the foundations of vibration machines and the walls of the building;

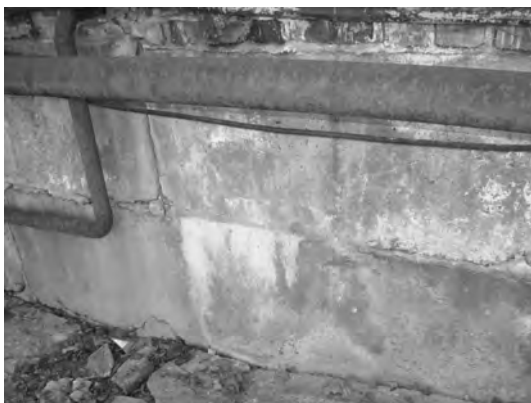
Although that reinforcement created the effect of tapes and reduced the significant development of cracks in brick walls (photo 3, 4), the destruction of the foundations of the ARS building wasn't stopped because of the influence of the vibration from compressors. Besides, the foundations are constantly washed out by the waste water and have too little depth of laying with different base of supporting of their soles.

*Photo 3. The state of the foundation of wall blocks by axis "B" between axes "1/1" ... "3". Moving units by horizontal and vertical seams and by contact of walls and blocks*

Moreover, several areas of small depth of foundation laying from the soil surface were identified by the results of shurfing. Uneven settling of foundations was as a result. Strong influence of vibration and further destruction of the tape foundations are due to the fact that the sole of the foundations under the vibration equipment is at the level or higher than the surface paving of axis "B" and are based on technogenous and settling soils. Because of this, there is a slope of the foundations of equipment to axis "B". The fact of further destruction is based on sliding by horizontal and vertical seams of concrete blocks and by the contact of walls and blocks. The violation of the verticality of the socle wall and cracks in vertical seams were also found (photo 3, 4).

6. to do reinforcement using drill piles  $\varnothing 200$  mm with supporting them in the soil 4 or 5 (Fig. 5) for ensuring the identical settling of the foundations. For creating the hard drive building to make the concrete jacket for impossibility of further destruction of foundations from vibration influences (Fig. 5).

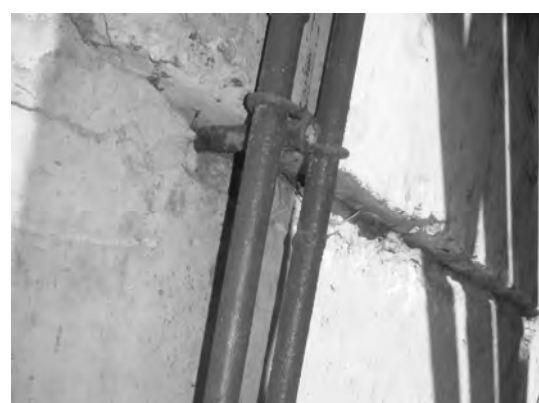
*Photo 4. The state of the foundation wall blocks by axis "A" between axes "2" ... "3". Deviation from vertical, moving units by seams*

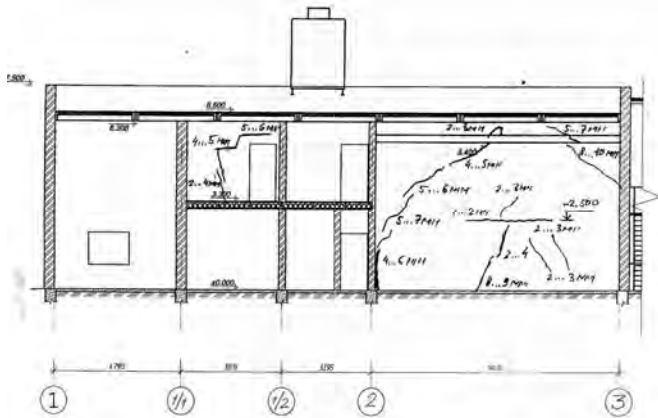
A lot of cracks of the walls of the building are seen because of the vibration of compressors and absence of the strain seams between concrete floor of the engine room and the walls (photo 5, 6, 7, 8, Fig. 3, 4). Let's emphasize that the greatest number of cracks of the walls all over the height of the building are along axis "B". This is especially due to the axis "2" ... "3" and "1" ... "1/1" where the compressors are situated and the waste water is drained. Besides a lot of slopping and vertical cracks of the inner wall along axis "2" are seen. It is related to vibration and defective drainage system of rainwater from the roof through the drain pipe inside the building. The slope of the cracks of the outside wall along axis "A" and at the crossing of axis "1" ... "A" means the settling of the corner of the building. The defective sewer pipes could be the reason of such situation. The destruction of brickwork made of two rows of lining above the

The development of the width of the opening of the cracks in the brick walls has been a bit stopped a bit by the arrangement of the system of the levers (from smooth armature class A240 Ø28), which were installed in three levels of wall height. Those reinforcement levers created the effect of clips and reduced further cracks development. However they did not do the main task – to provide the necessary bearing capacity of the foundations and to stop vibration and exploitation damages (as a result, the whole building begins to deviate from the vertical).

Fig. 3 The scheme of location of cracks along the axis "B"

4. to do paving along axis "B" in a right way, to make a rainwater drainage from the basement by the perimeter of the building to avoid soaking;
5. to make new beacons on the cracks width of opening more than 5 mm, to observe the width of their opening;

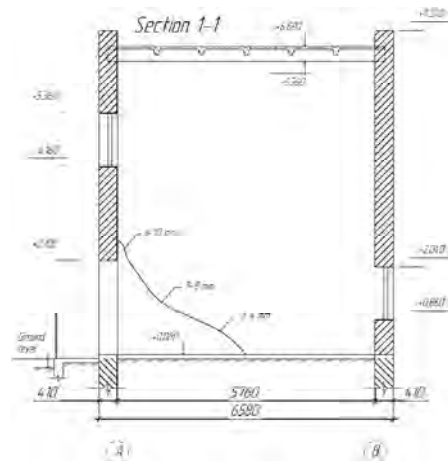
Fig. 4. The scheme of location of cracks along the axis "1"

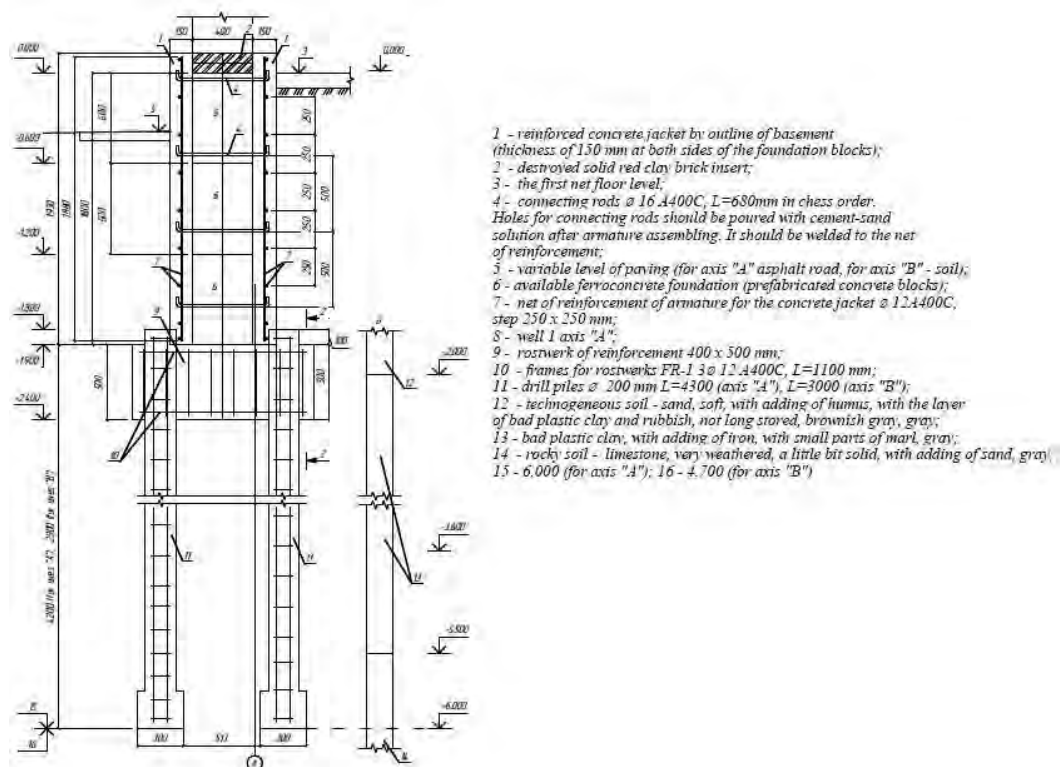
Fig. 5. The principle solution of basement reinforcement by using drill piles and concrete jacket
