EXPERIMENTAL DIAGNOSTICS AND STATIC ASSESSMENT OF FIRE DAMAGED STEEL STRUCTURE

In the paper are presented the results of diagnostics, tests of materials, numerical modelling and static analysis of the current state of the bearing steel structure of the hall after a fire and design of the actions for the repair of the damaged steel structural members.

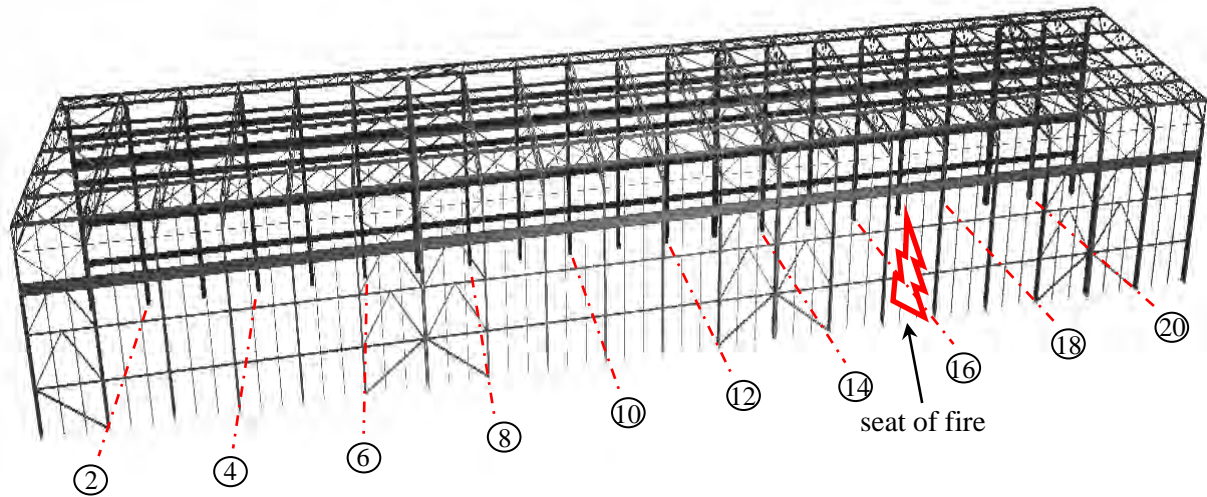
The present hall building was built and put into use in 1965 (Fig. 1). Bearing system of the hall create columns of welded steel I-1100-sections with transverse stiffeners, situated on one side of the outer plane of the building and reinforced concrete columns mounted on the other side of the building. The bearing structures of the roofing create steel truss tie-beams. The main girder of the crane runway is made of a welded steel I-1200-section [2].

Fig. 1. Model of the hall with marked axes of the individual transversal bonds and denotation of the seat of fire
