EMERGENCY CONDITION OF LOGGIAS IN BUILDINGS WITH SUPPORTING BRICK WALLS

All these construction errors, individually or in combination, often lead to damage or destruction of the load-bearing structures of loggias, which, in turn, makes the building an emergency. An example of such a situation is the condition of loggias in an existing building with load-bearing brick walls on the street. Volodymyra Velykoho, 44 in the city of Lviv.

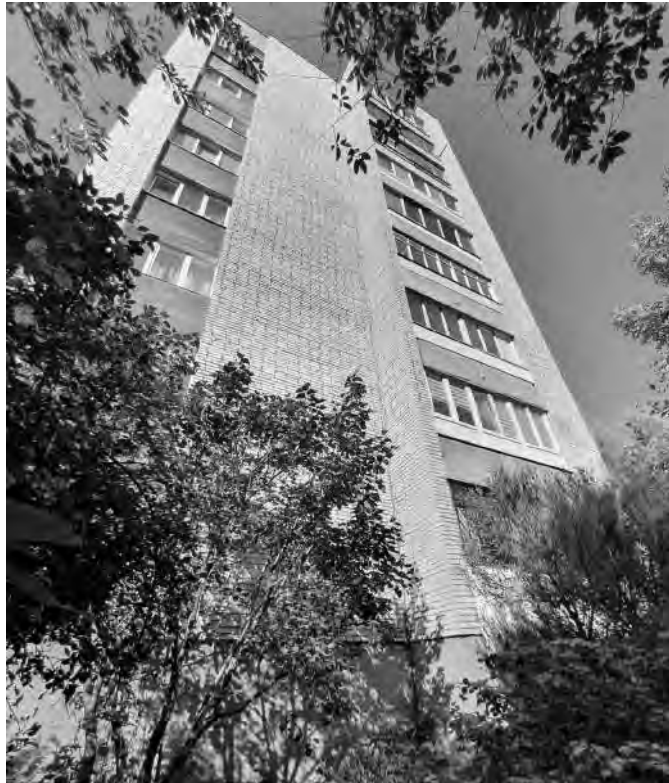
Fig. 1. Scheme of the building

Structural scheme of the building, part of which was inspected, with longitudinal and transverse brick load-bearing walls and horizontal overlapping disks. Residential building (Fig. 1).
