*Oleh Rybchynskyi*

## PROBLEMS OF RESTORATION OF NATURAL STONE MONUMENTS LOCATED IN THE CITY PARKS

**Abstract.** In the given article the problem of restoration of natural stone monuments, located in the city parks, is analyzed. The main causes of stone deterioration, as well as programs and techniques of conservation and restoration of monuments, located in city parks, have been determined.

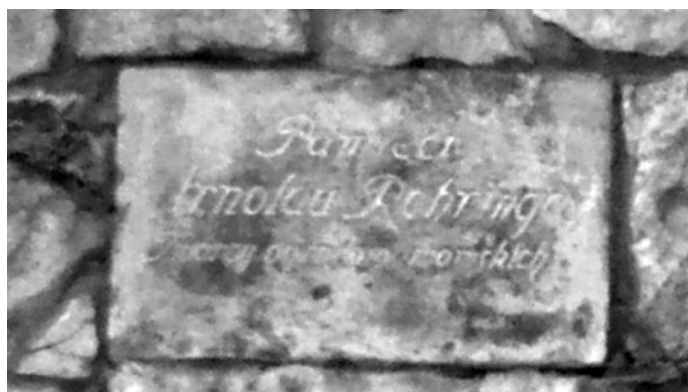
In spring 2016 restoration works of the memorial plate of Arnold Röhring in the Stryiskyj park were conducted. The monument was in a poor condition. A visual inspection of it showed a solid cement layer over the plate, absence of several letters in the main inscription and some unclear letters in the auxiliary text on the plate (Fig. 1).

**Fig. 1.** The memorial table before restoration.  
Photo by the author

Before starting restoration works a restoration program was worked out:

1. Preliminary examination;
2. Diagnosis status and material of monument;
3. Conducting conservation work;
4. Structural strengthening of monument;
5. Implementation of local reconstruction;
6. Expressiveness of forms and details of monument;
7. Implementation of glazing;
8. Blocking the cement inserts and putty.

1. Water and dry cleaning of the surface of volatile contaminants;
2. Steam cleaning of the surface from sustainable chemical, biological and atmospheric formations affecting the monument surface;
3. Chemical cleaning of the surface from persistent pollutants;
4. Removal of later aggressive and cement inserts;
5. Filling-in of cracks and caverns with selected materials;
6. Implementing of additions to lost fragments with compatible materials;

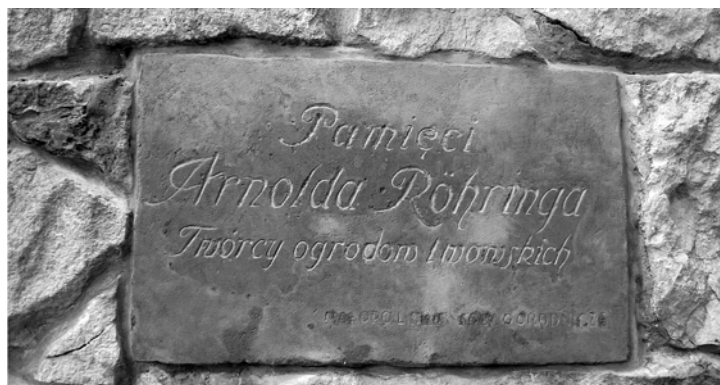
As a result of the undertaken restoration works, the surface cement coverage of the slab has been taken off, additions of the damaged parts have been made, the lost letter inscription was restored, as well as the auxiliary inscriptions (Małopolskie Tow. Ogrodnicze). 60 % of the surface plates have been restored. Also, the filling-in of edges around the plate's perimeter was done to protect it from excess moisture that comes through the capillaries of the spring. (Fig. 2) After the clearing the memorial plate got back its authentic dark-ocher color.

**Fig. 2.** Memorial plate after restoration. Photo by the author
